**CONDITION BASED
ASSESSMENT & WATER
MASTER PLAN**

for
Casitas Municipal
Water District

October 2018

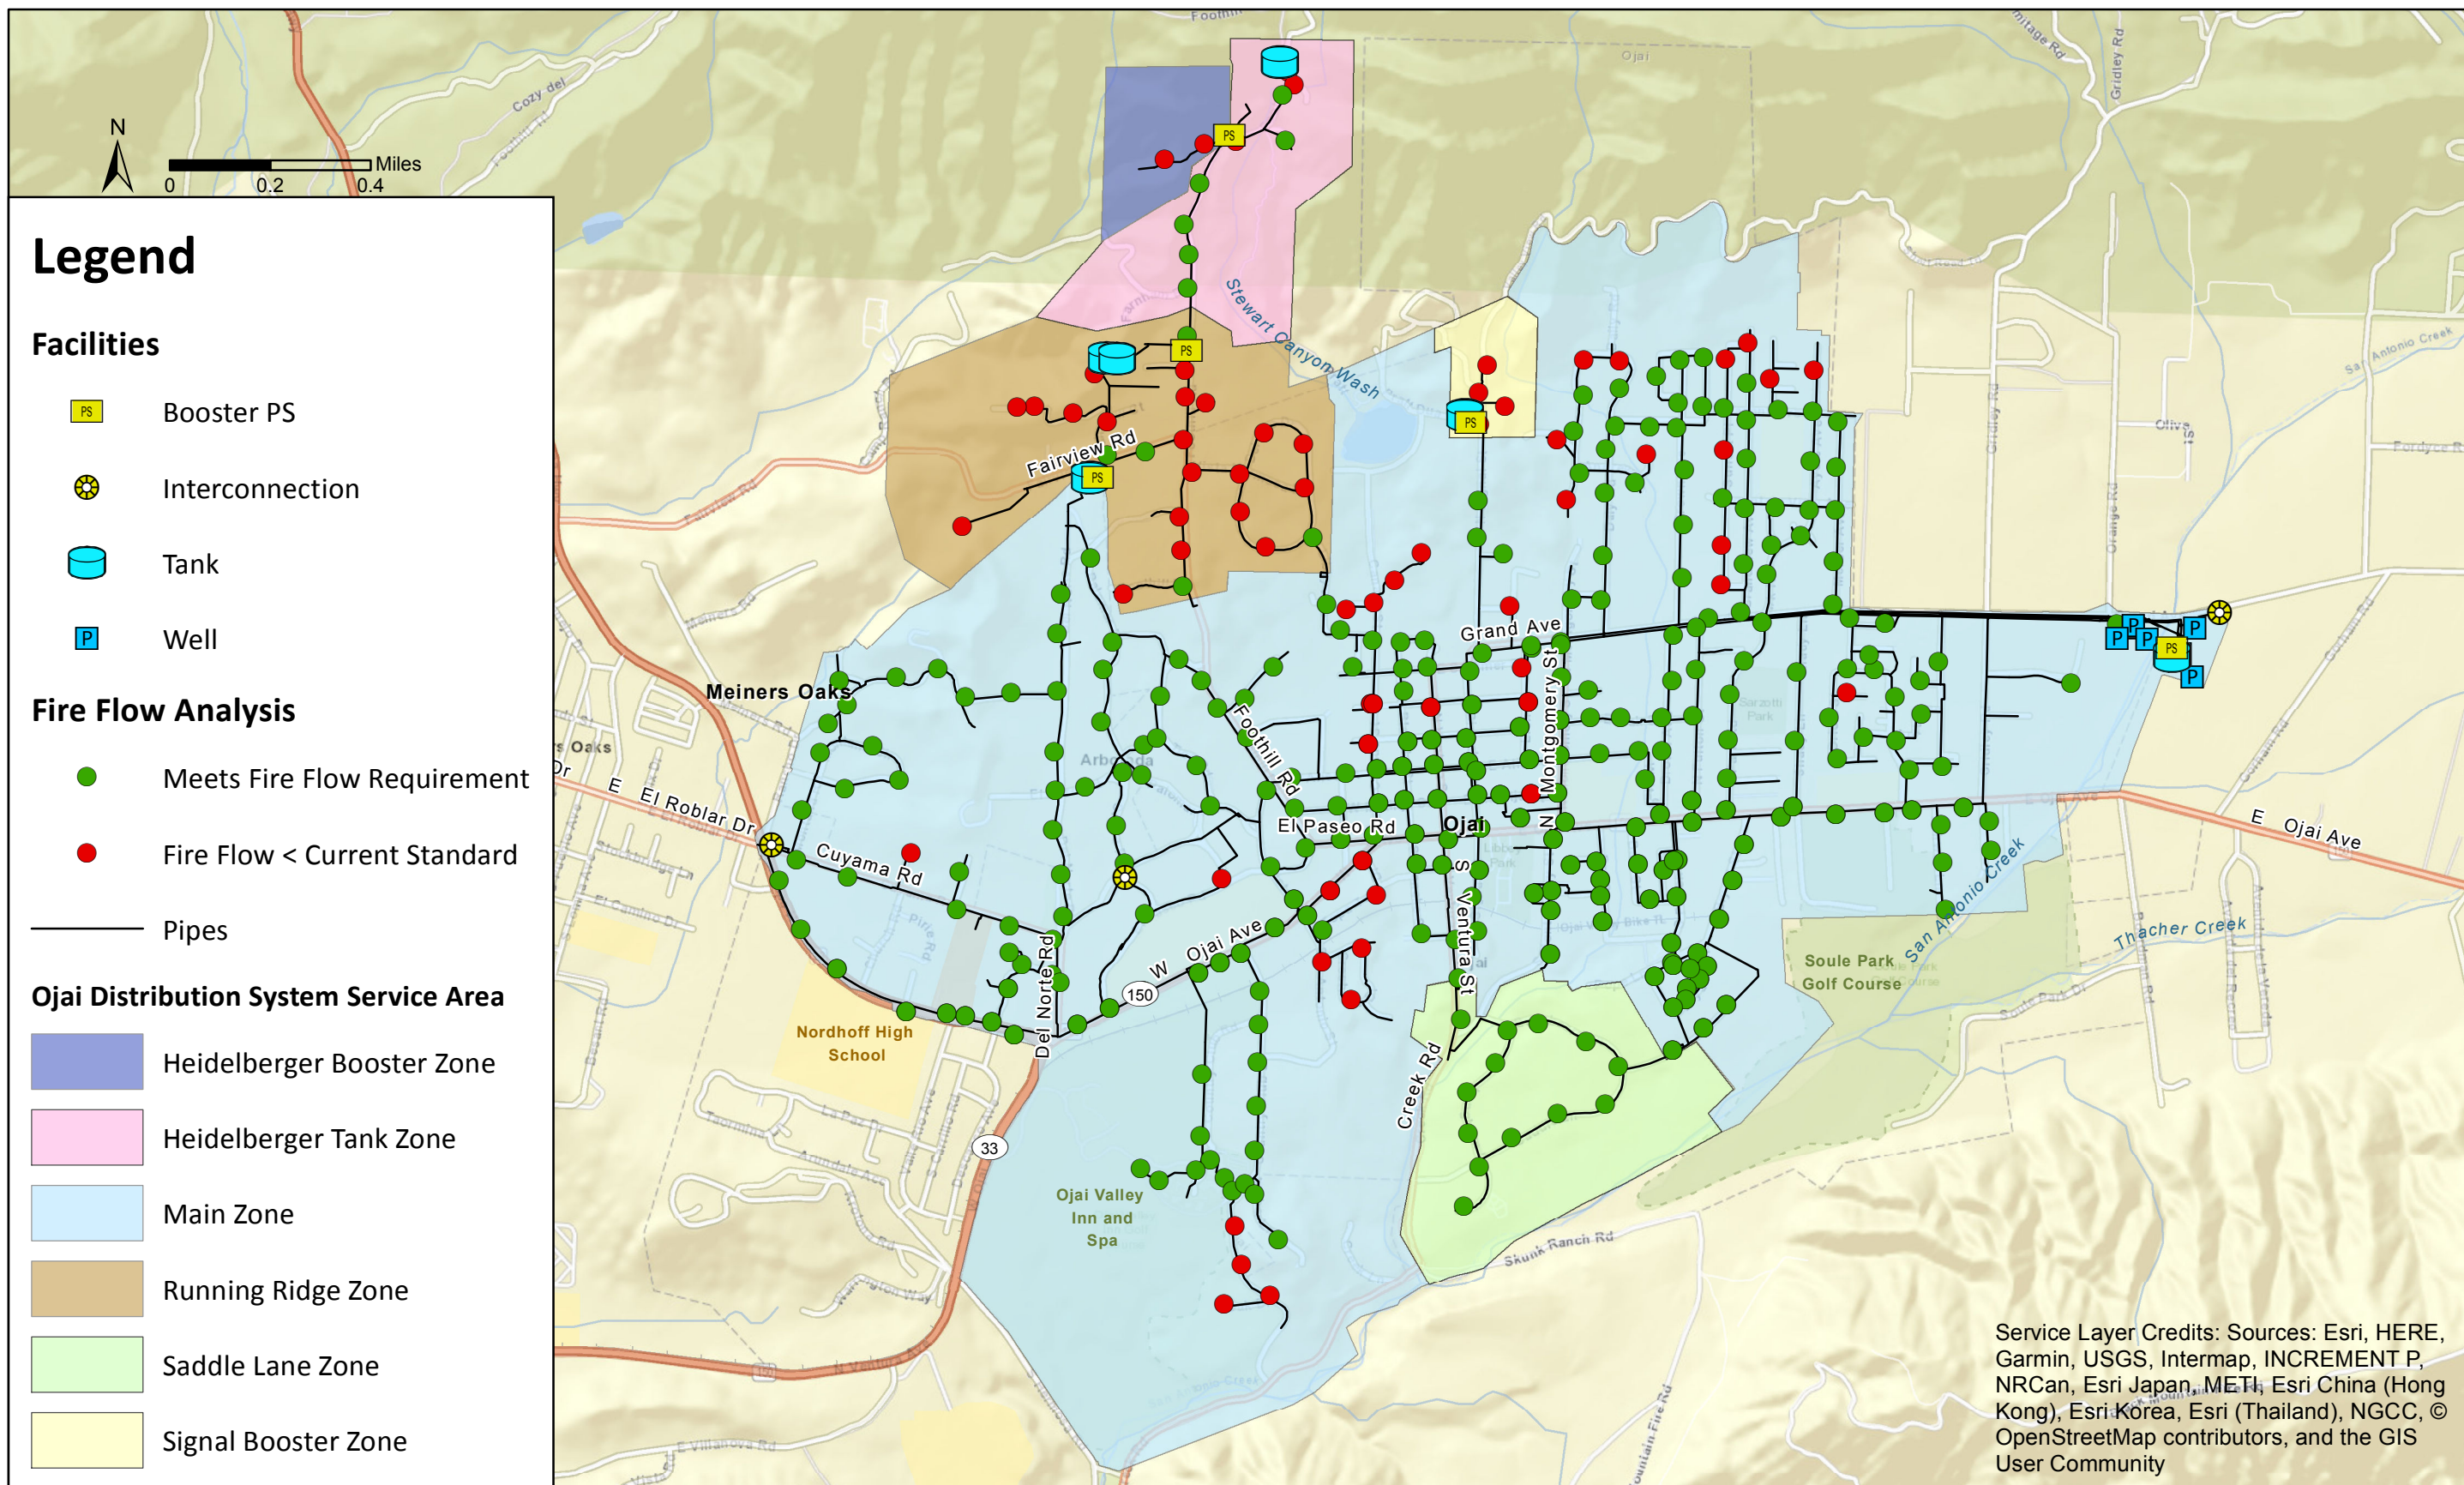
Figure 8-3. Current Fire Flow Deficient Hydrants in the Ojai Distribution System

The available fire flow is highly dependent on pipeline size and available looping in the distribution system. Locations comprised of small diameter cast iron mains, especially old mains that are likely rough and have tuberculation that further reduce the hydraulic diameter, and locations with limited looping, have the lowest available fire flow. Along with pipe capacity, hydrants that experience low pressures were predicted to also have a low available fire flow. This is because the model predicts fire flow by applying the 20 psi minimum to the hydrant and calculating how much water can be flowed at that pressure. These hydrants are likely to draw more flow than predicted, but the pressure in the system may drop below the 20 psi requirement. The modeling analysis for predicting fire flow with 20 psi residual is conservative and was assumed to be adequate for the development of capacity projects to improve fire flow.

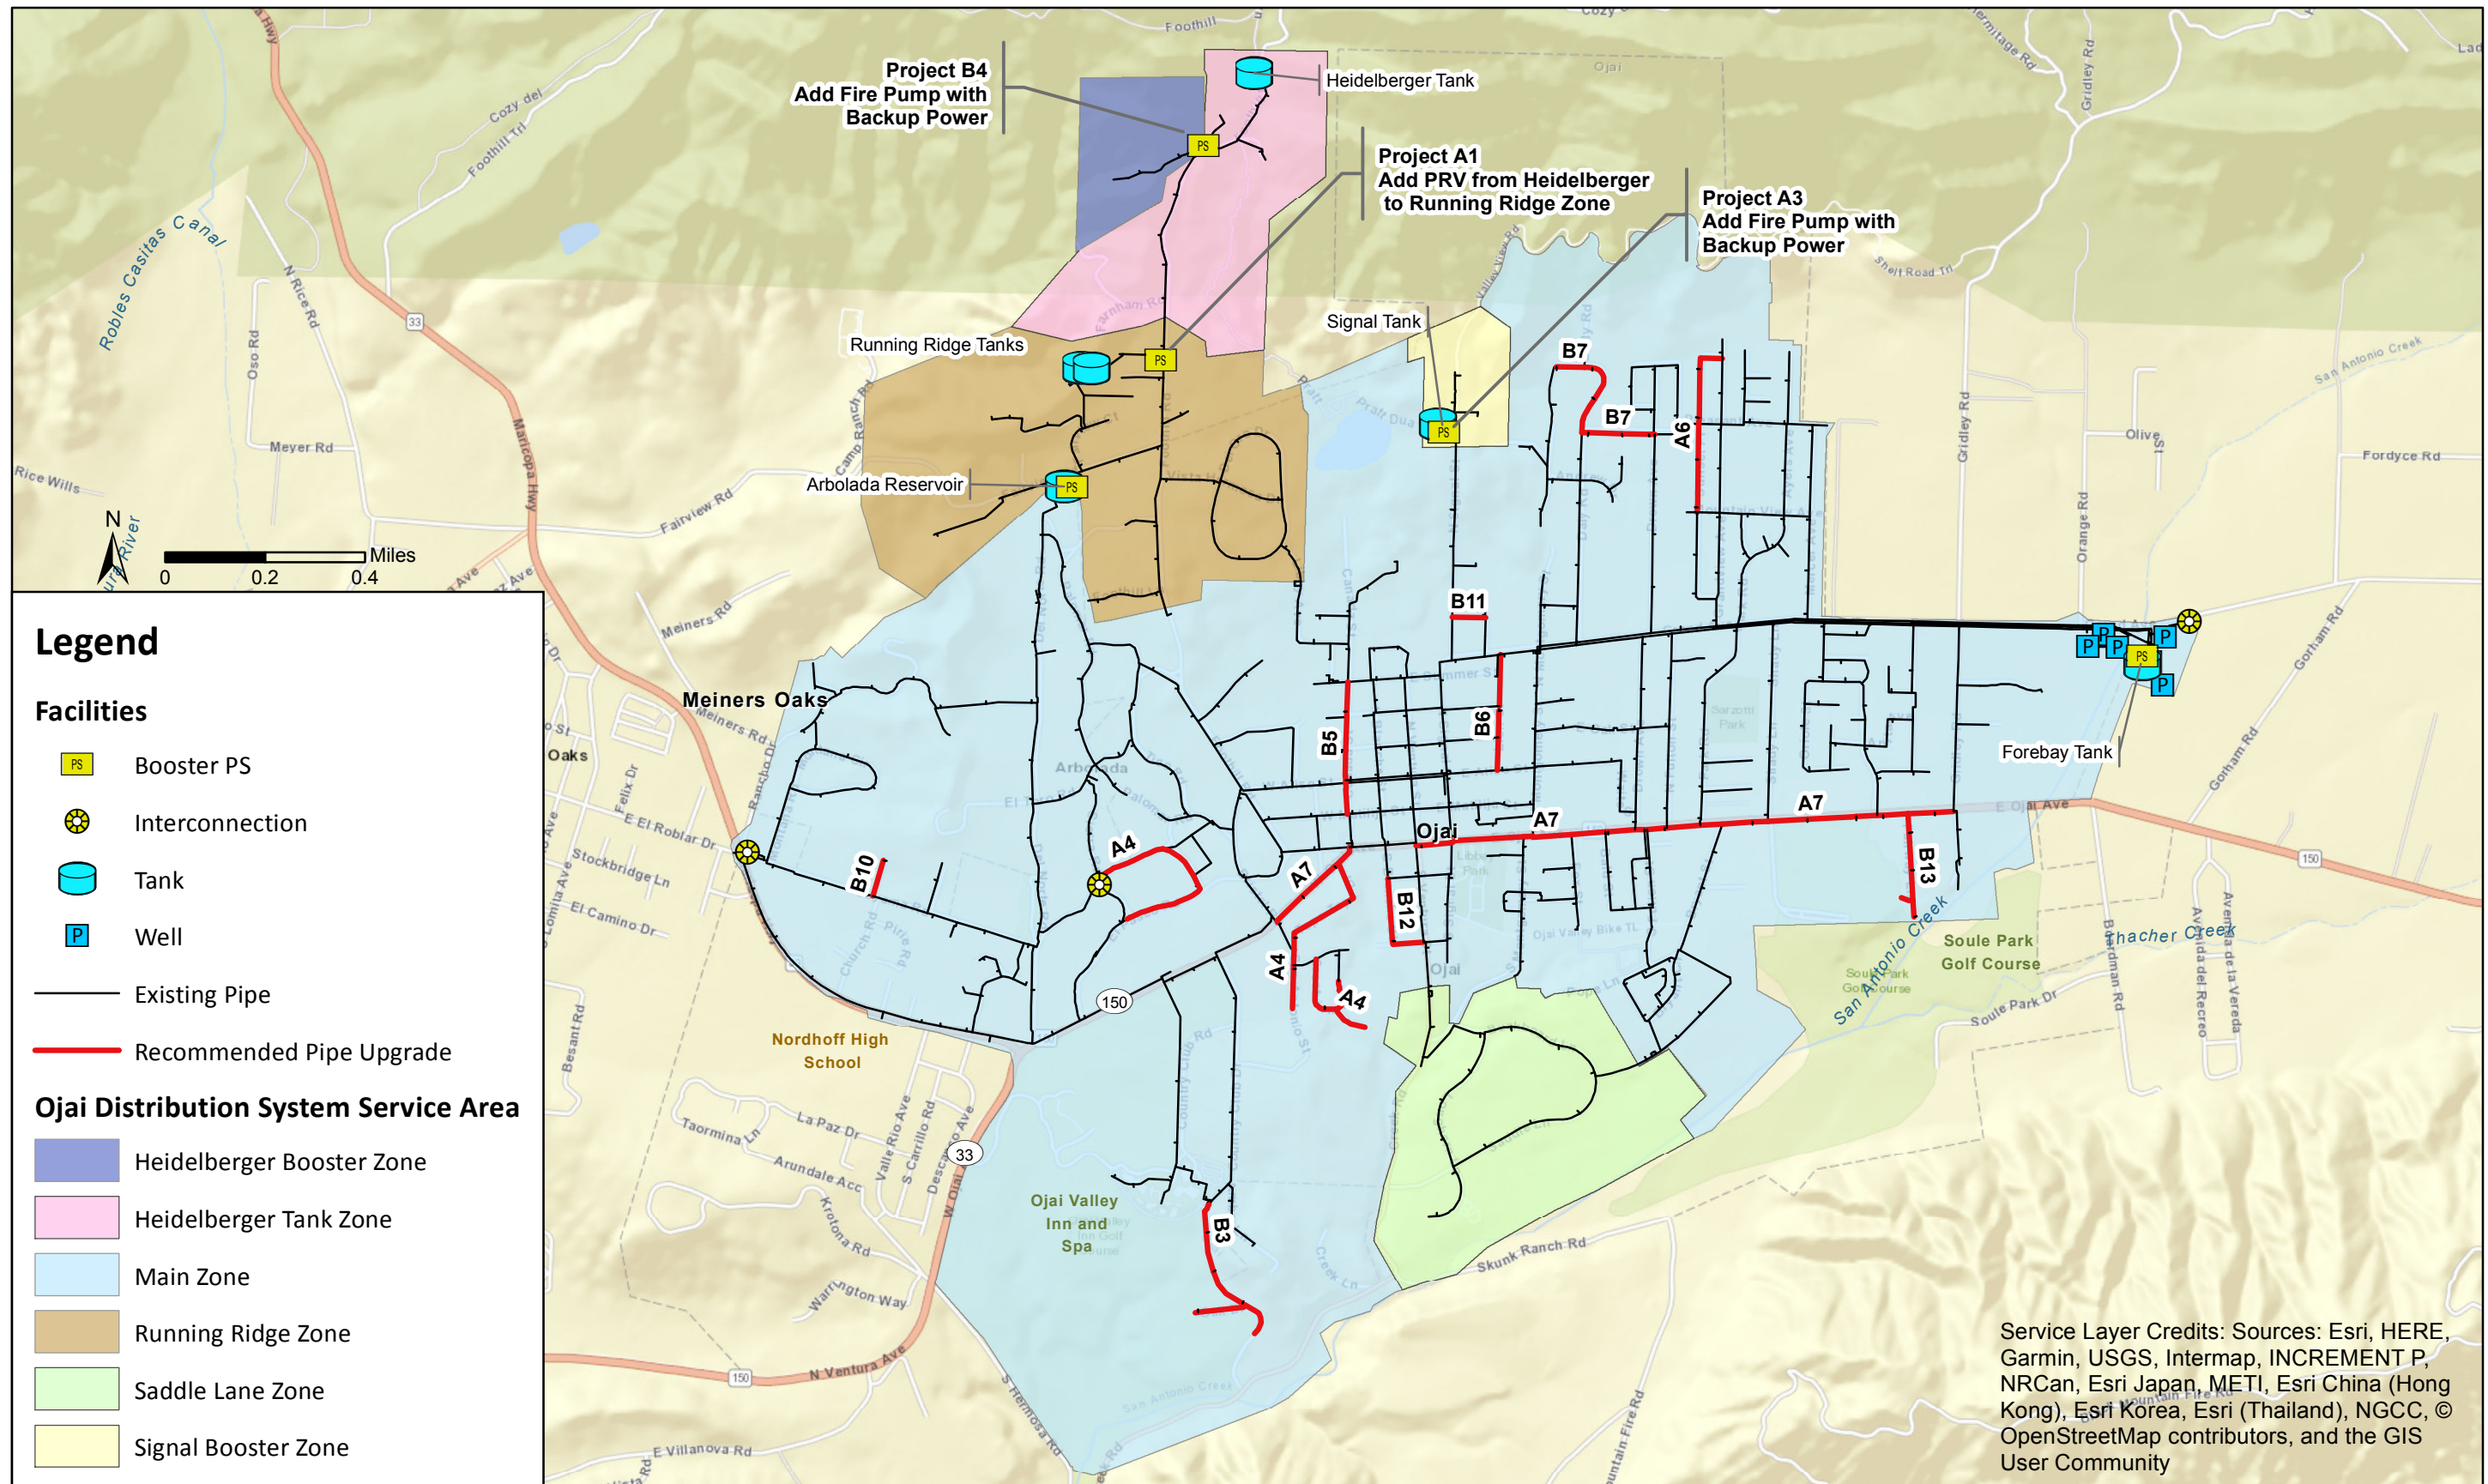
Figure 8-4. Recommended Fire Flow Projects

Projects to improve fire flow were developed by upsizing pipelines that restrict fire flow and adding new pipelines to create additional looping in the system, then rerunning the model. Projects were iterated until the fire flow requirement was met while minimizing costs of the upgrade projects. Projects were also limited to roads in Ojai that have not been paved within the last year. Most of the recommended projects include upsizing aging 4-inch and 6-inch cast iron mains that restrict fire flow or upsizing dead-end mains. Overall, WSC recommends upgrading about 4.5 miles of small diameter pipelines with 8-inch diameter pipe to improve fire flow through the Ojai distribution system. Besides pipeline projects, it is recommended that fire pumps are installed to supply fire flow to the Signal and Heidelberg Boosted Zones and a PRV is added at the Valley View BPS to provide fire flow for the Running Ridge Zone. In addition to automatic fire flow runs in the hydraulic model, the available fire flow was manually checked in the model by applying the fire flow requirement as demands between multiple hydrants and observing the zone's pressure response. During a fire, it is likely that multiple hydrants will be used and their collective flow rate must meet the fire flow requirements.

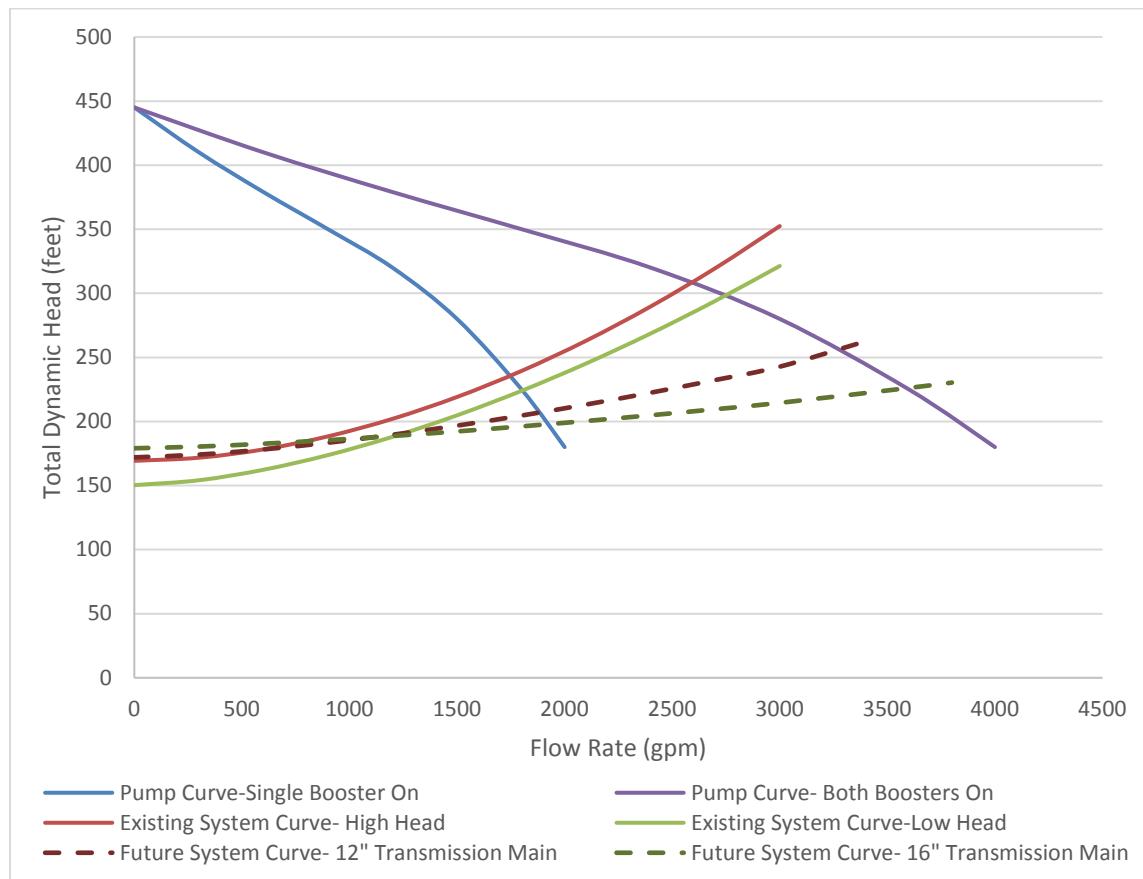
Figure 9-2. San Antonio Pump Station Pump and System Curves

Alternatively, the system curve can be flattened by reducing head losses through the Main Zone between the San Antonio BPS and the Arbolada Reservoir. This can be accomplished by replacing aging mains that have roughened over time with new smoother pipes and replacing undersized mains. The 12-inch transmission main through the Main Zone is constructed of cast iron and was installed in 1932. It is expected that this transmission main is very rough due to the material and age, and replacing it will greatly improve head losses through the Main Zone. The model was used to evaluate the system curve after all the recommended pipeline projects have been completed, including the fire flow projects and pipeline condition assessment projects. The system curve was also evaluated with the pipeline projects completed and the 12-inch transmission main increased to a 16-inch main. These system curves are included in Figure 9-2 and the expected future flow and pressures are listed in Table 9-3.

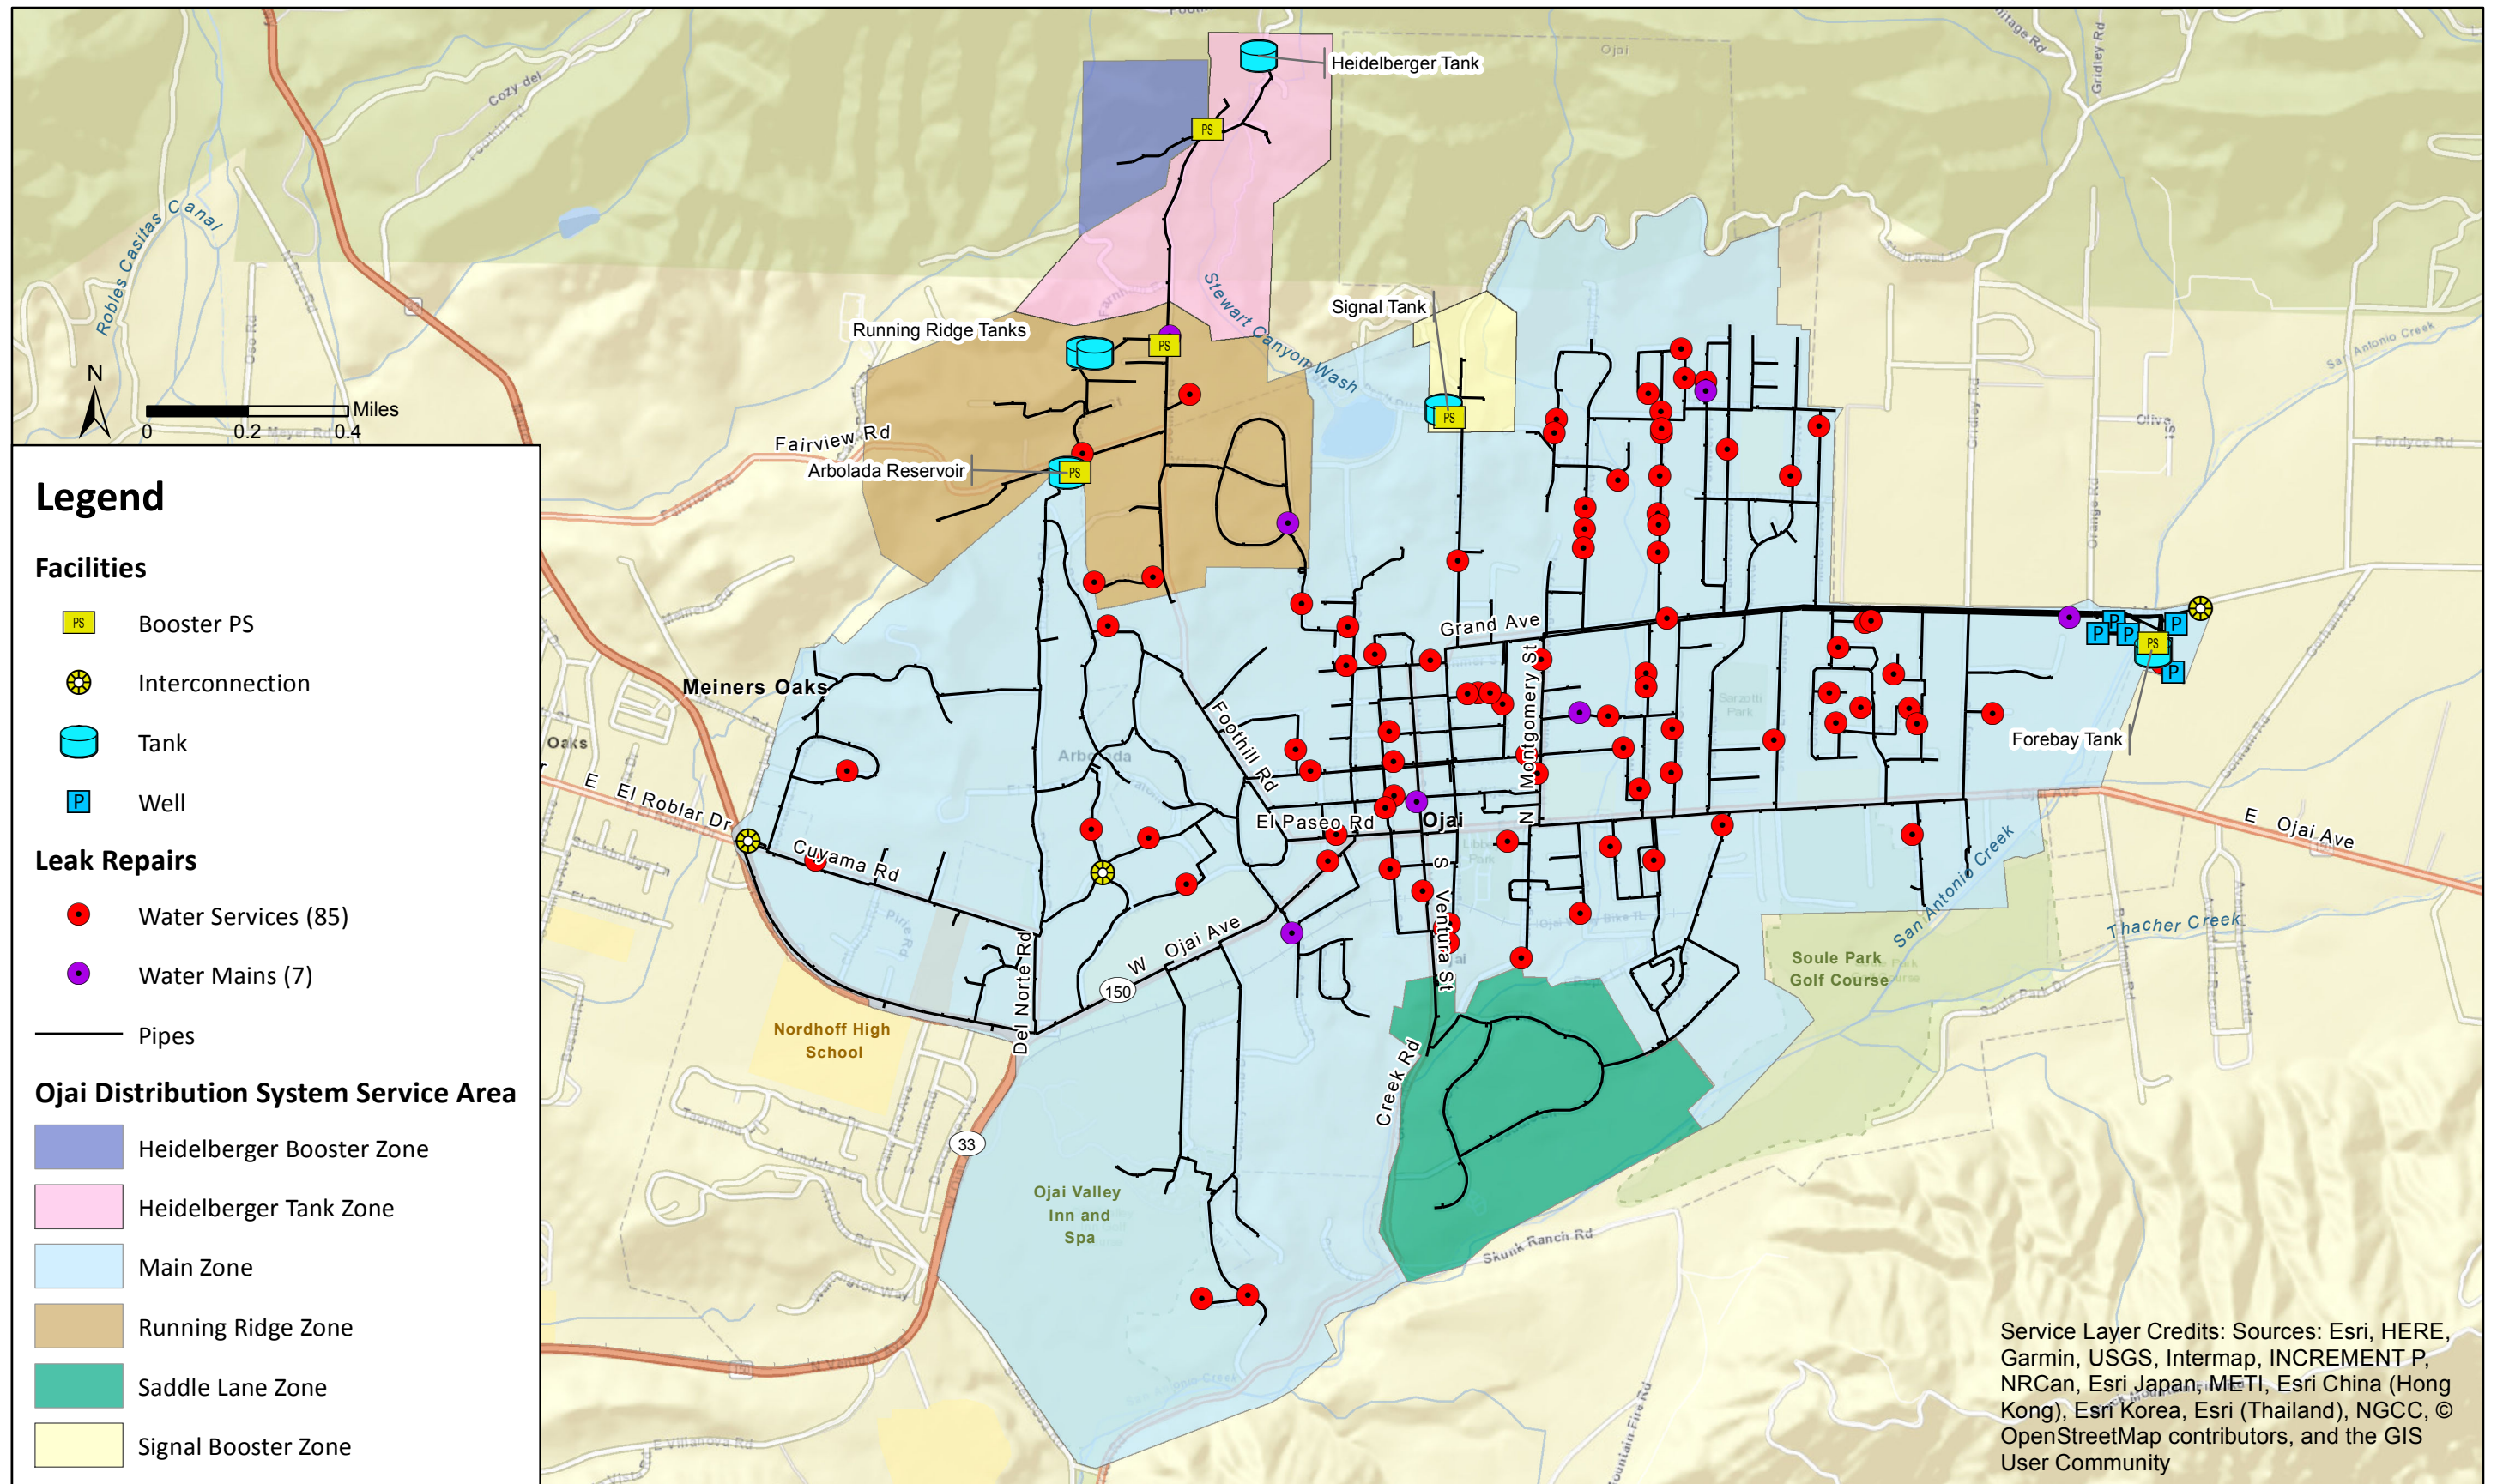
Figure 10-1. Leak Repairs from June 2017 through May 2018

It is recommended that CMWD repair the identified leaks that have not already been repaired, and plan to regularly survey the system to update maps and identify leaks because new leaks are always developing in the water distribution system due to the aging infrastructure. Regularly scheduled leak surveys are beneficial to reduce water loss and it reduces overtime costs due to emergency repairs. Water leaks have also been known to cause damage to nearby roads and other infrastructure, and they typically get larger with age. As a result, it is recommended that CMWD proactively locate and repair leaks on a scheduled basis.

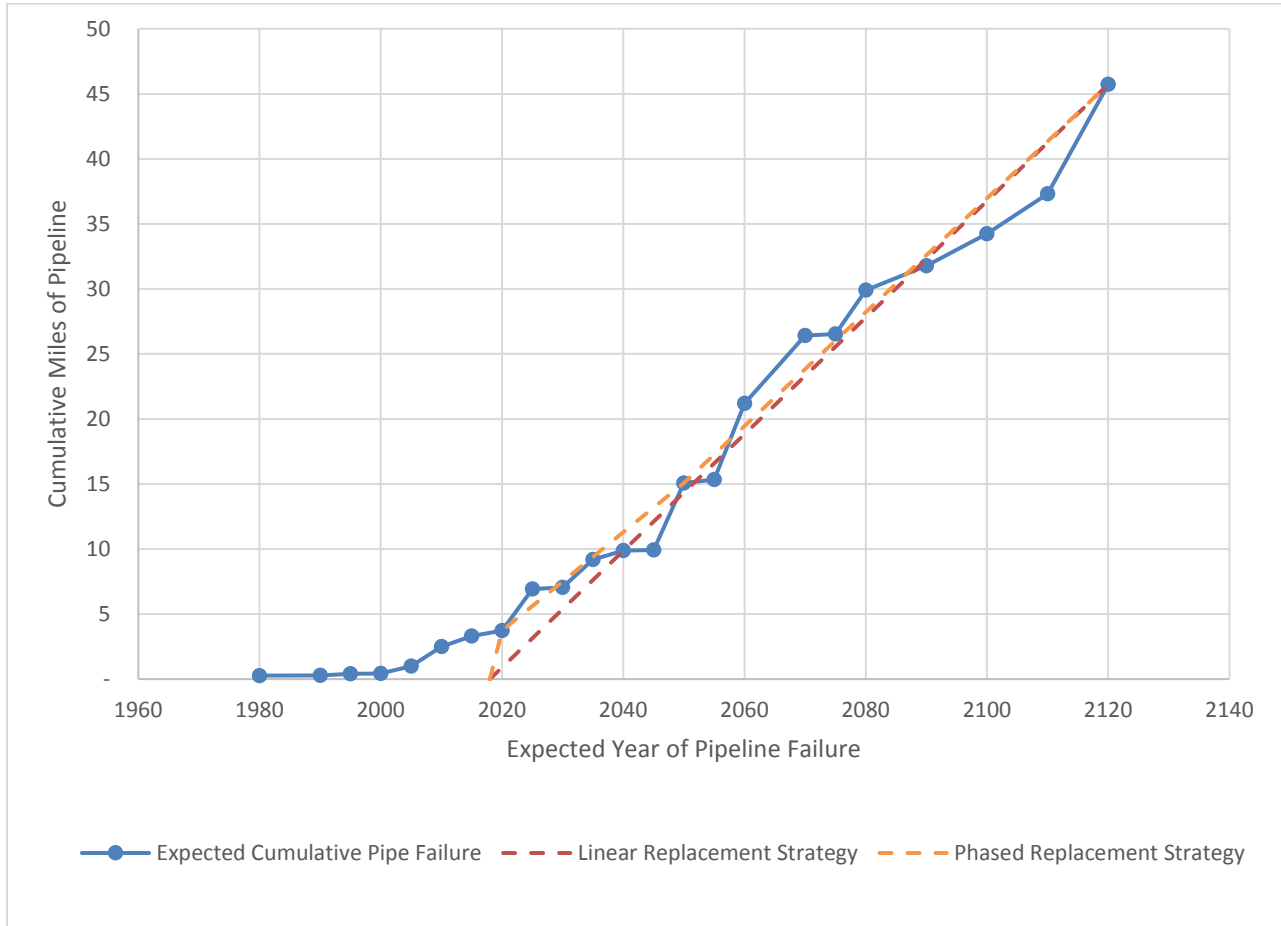
Figure 10-7. Expected Cumulative Miles of Pipeline Failures and Replacement Strategies

Under the linear replacement strategy, pipeline replacement needs to occur at a rate of 0.45 miles per year, about 1% annually. Under the phased replacement strategy, the recommended length and rate of pipe replacement varies based on the year:

For planning purposes, and to prevent a massive pipe failure in the distribution system, CMWD should actively replace aging pipelines. Replacement strategies presented in Figure 10-7 include: (1) a linear replacement strategy; (2) a phased replacement strategy that includes an initial large infrastructure improvement plan to better match the estimated pipeline failure curve.
