2011 Robles Fish Passage Facility Progress Report

Casitas Municipal Water District
1055 Ventura Avenue
Oak View, California 93022

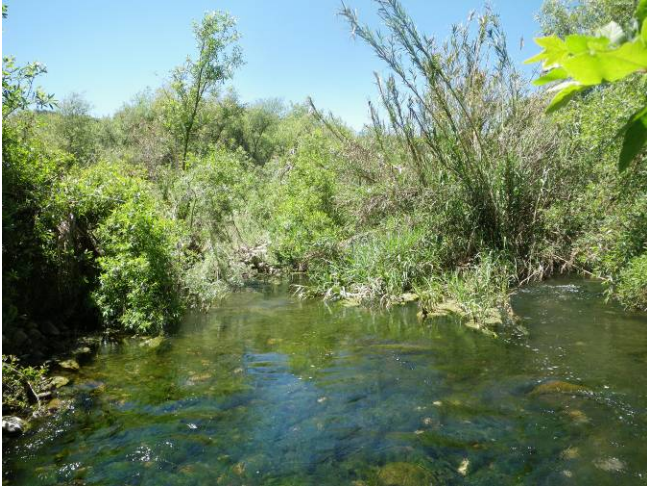
Appendix 15c. Photos of Site 4 impediment on 26 April 2011 during 31 cfs discharge release from Robles Fish Facility, looking from: (A) downstream, (B) upstream, (C) right to left bank, and (D) left to right bank.

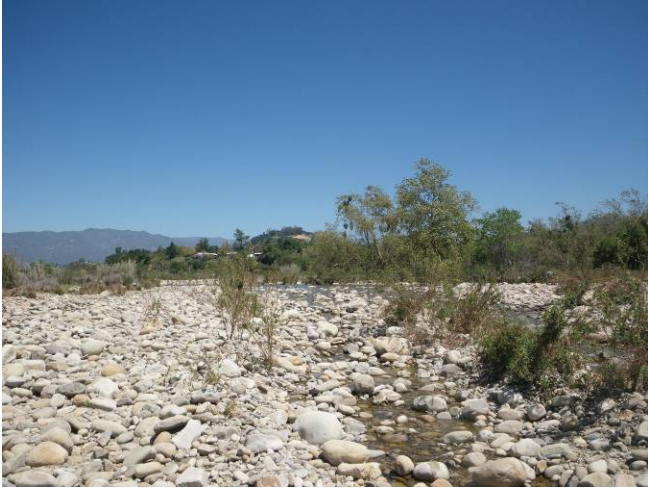
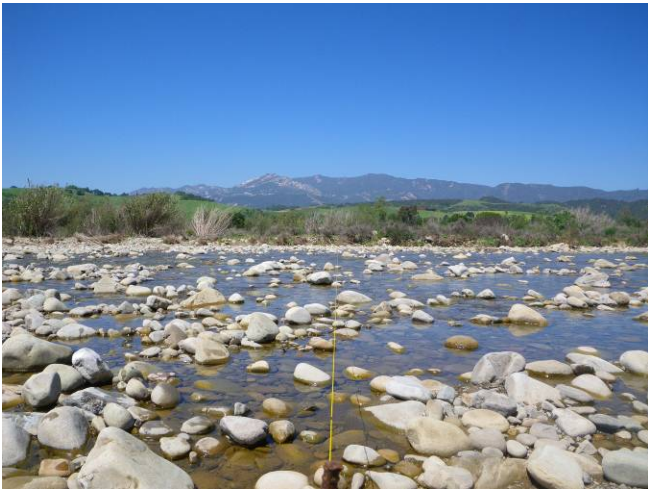
Appendix 15d. Photos of Site 5-2 impediment on 05 April 2011 during 30 cfs discharge release from Robles Fish Facility, looking from: (A) downstream, (B) upstream, (C) right to left bank, and (D) left to right bank.

The March high-flow event caused substantial changes at Site 5. The primary channel changed from the right (Site 5-1) to the left channel (Site 5-2) due primarily to sediment scour and some deposition. Previously, approximately 80% of the discharge was flowing through Site 5-1. After the high-flow event, approximately 60% of the discharge was flowing through Site 5-2. In fact, there was significantly more discharge flowing through Site 5-2 than 5-1 after the high-flow event (one-sided p-value < 0.001, t-test). Because Site 5-2 was the primary channel, it was used in all analyses. Site 5-2 was surveyed five times after the high-flow event. Robles discharge ranged from 30 to 74 cfs. The resulting minimum discharges required to meet the Thompson criteria were 55 and 14 cfs (Appendix 7). One of the resulting minimum discharges required to meet the three other criteria was negative and therefore not plausible. The regression was then forced through the origin and the resulting discharges ranged from 11 to 23 cfs. The minimum discharge to meet the Thompson criteria when using the site discharge were 48 and 3 cfs (Appendix 8)

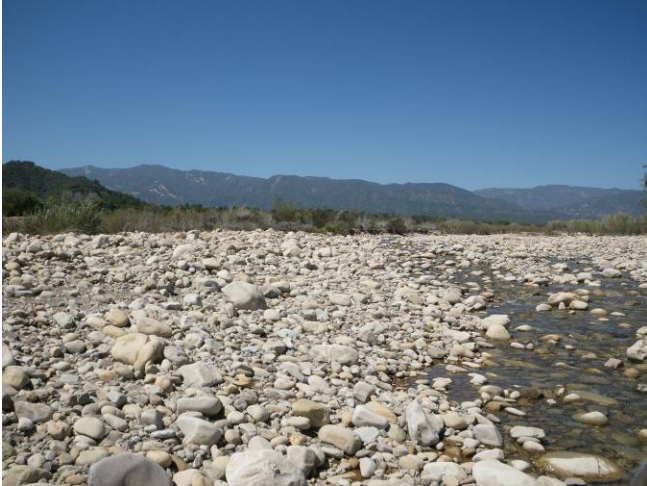
Appendix 15e. Photos of Site 6-2 impediment on 05 April 2011 during 30 cfs discharge release from Robles Fish Facility, looking from: (A) downstream, (B) upstream, (C) right to left bank, and (D) left to right bank.

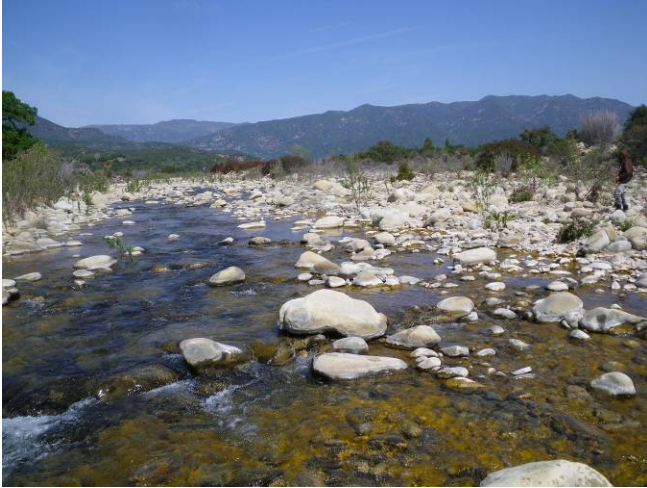
Appendix 15f. Photos of Site 7 impediment on 26 April 2011 during 31 cfs discharge release from Robles Fish Facility, looking from: (A) downstream, (B) upstream, (C) right to left bank, and (D) left to right bank.

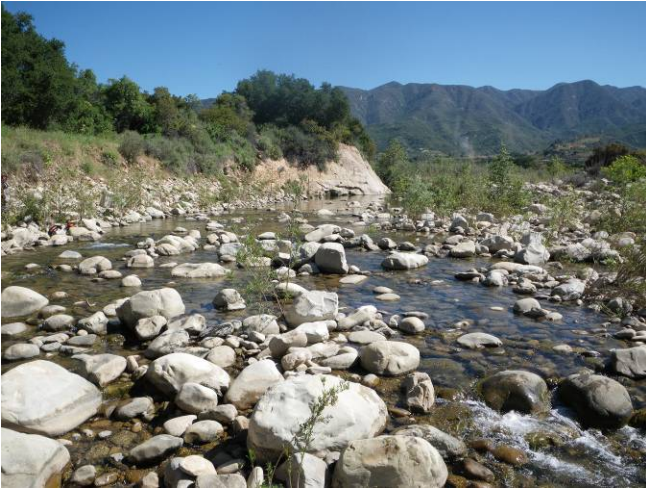
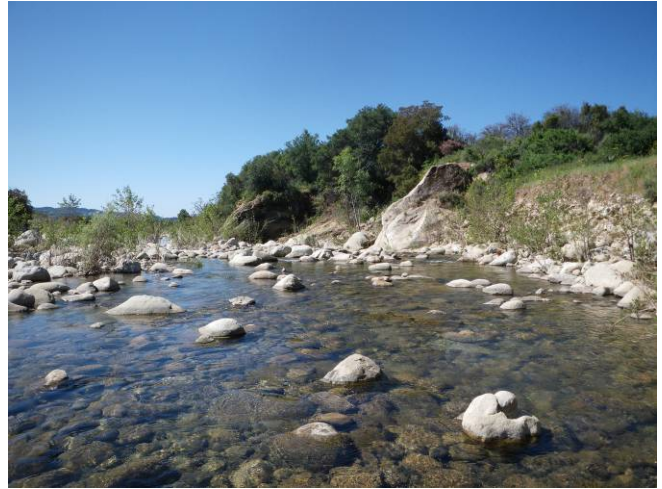
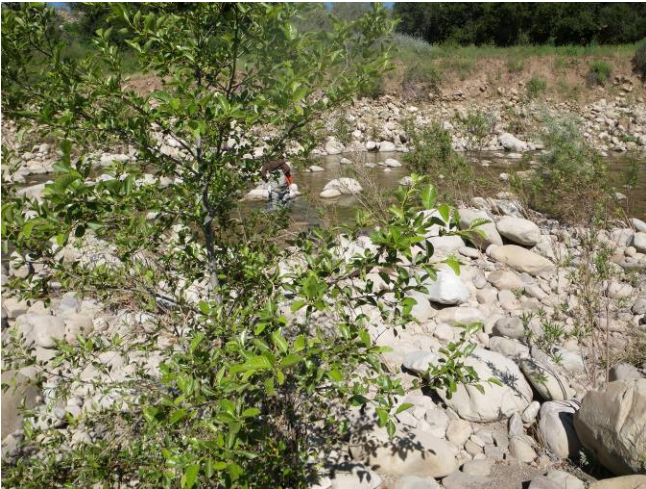
Appendix 15g. Photos of Site 8 impediment on 26 April 2011 during 31 cfs discharge release from Robles Fish Facility, looking from: (A) downstream, (B) upstream, (C) right to left bank, and (D) left to right bank.

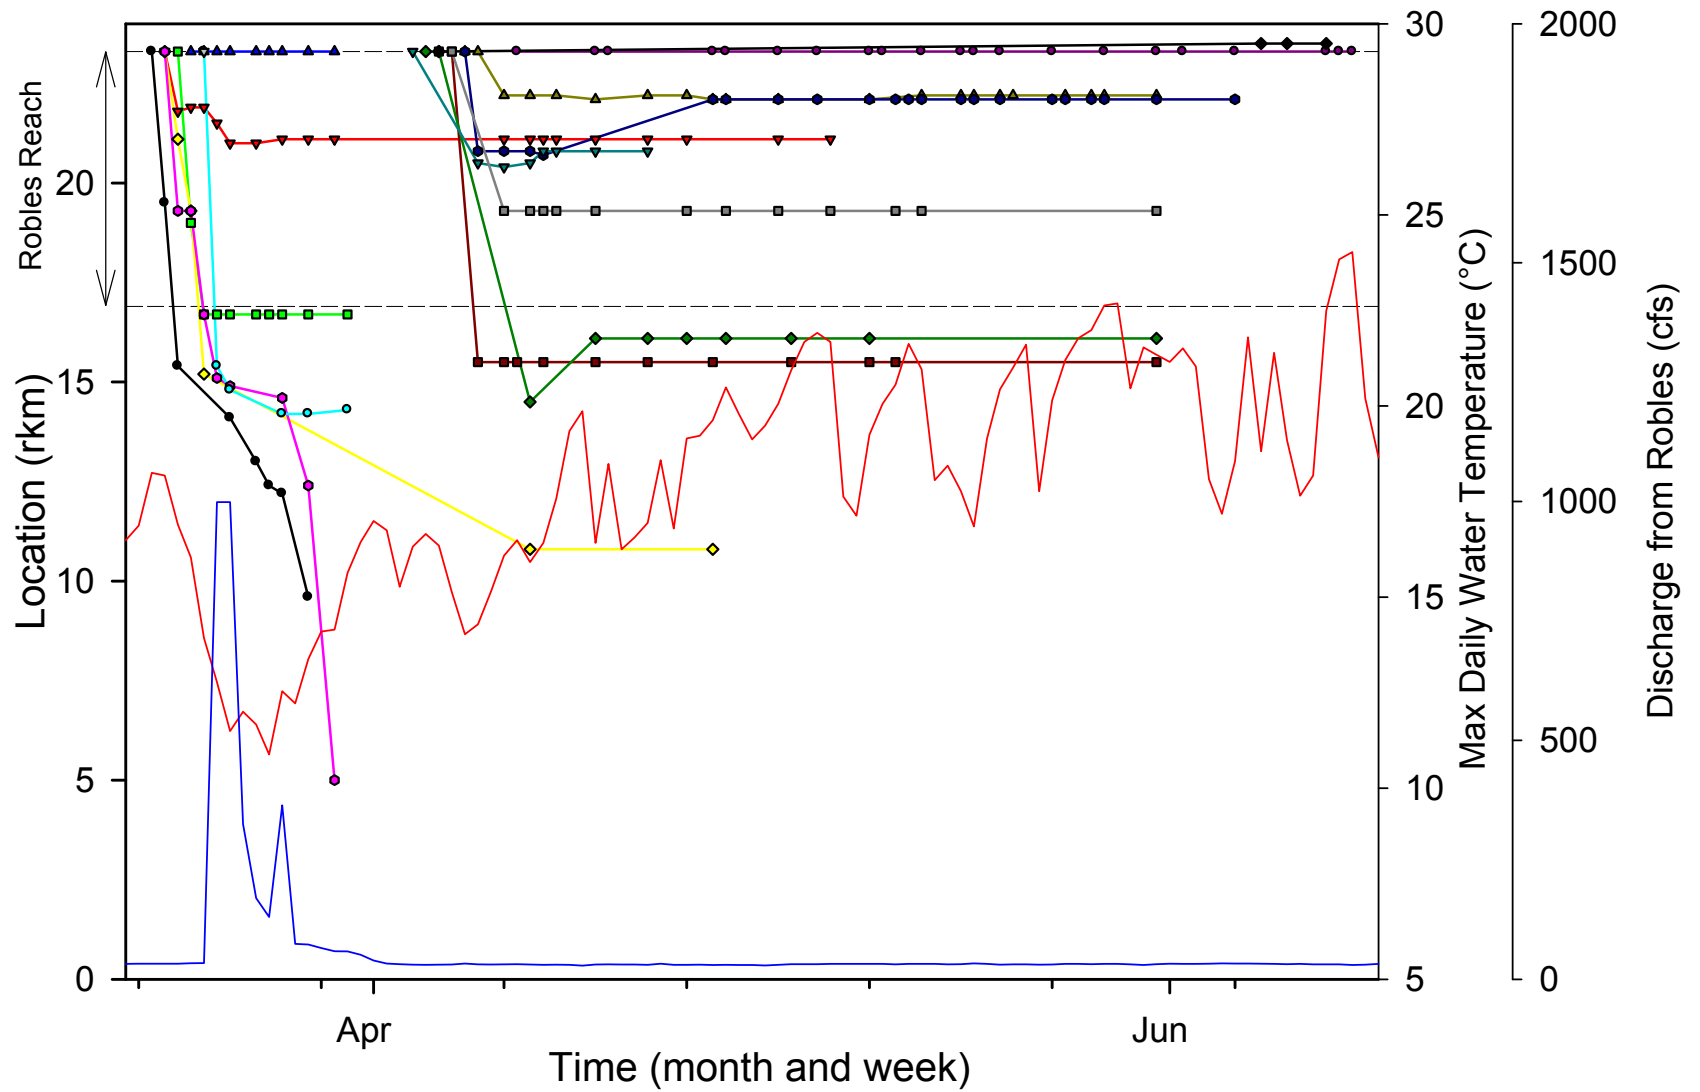
Appendix 34. Location and date of radio-tagged *O. mykiss* smolts released downstream of the Robles Fish Facility in March and April of 2011. Red line is maximum daily water temperature downstream of the Robles Fish Facility and the blue line is discharge from Robles. The Robles Reach is indicated by the two horizontal dashed lines.

Of the 16 smolts tagged and released downstream of the Robles Fish Facility, 7 smolts were found to have migrated through the Robles Reach (Appendix 34). The number of days to migrate through the Robles Reach ranged from 1 to 8 days and the mean was 3 days. This was a mean migration rate of 2.2 km/day. The range of discharges from Robles during the period from release to initial detection downstream of the Robles Reach was from 30 to 33 cfs for all but one of the tagged smolts. One smolt was detected downstream of the Robles Reach one day after release; a migration rate of about 6 km/day. This occurred as flows were increasing during the March high-flow event. The remaining 9 smolts were found to have moved less than 4 km downstream of the Robles Fish Facility. It appears that a high rate of tag regurgitation occurred during the study. Of the 16 smolts tagged and released downstream of the Robles Fish Facility, 10 smolts appeared to regurgitate their tags. The range of days to regurgitation was estimated to be from 1 to 18 days and the mean was about 6 days. This did not include one *O. mykiss* that was found to move upstream of the Robles Fish Facility. Due to the length of time from release until it was found, an accurate time to tag loss could not be calculated.

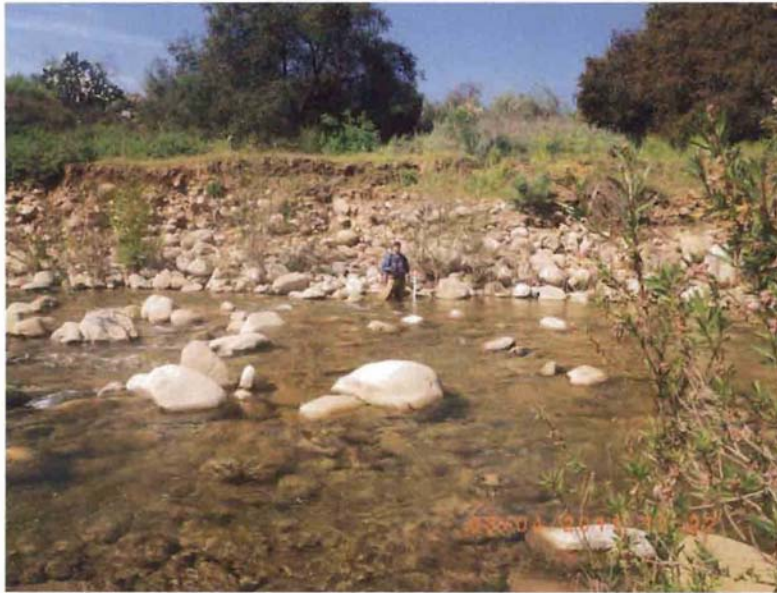
Figure 1. Approximate location of Casitas' Site 8 transect near OVLC pools in boulder run habitat. Person on West bank positioned at GPS coordinate from Casitas' Table 2 ($34^{\circ}12'15''$, $119^{\circ}17'36''$).
