Board Meeting Agenda

CASITAS MUNICIPAL WATER DISTRICT
December 11, 2013
3:00 P.M. – DISTRICT OFFICE

2013 Robles Fish Passage Facility Progress Report

2014 Monitoring and Evaluation Study Plan for the Robles Fish Passage Facility and Related Studies

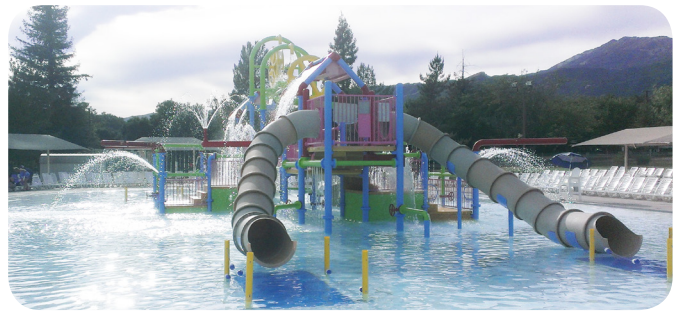
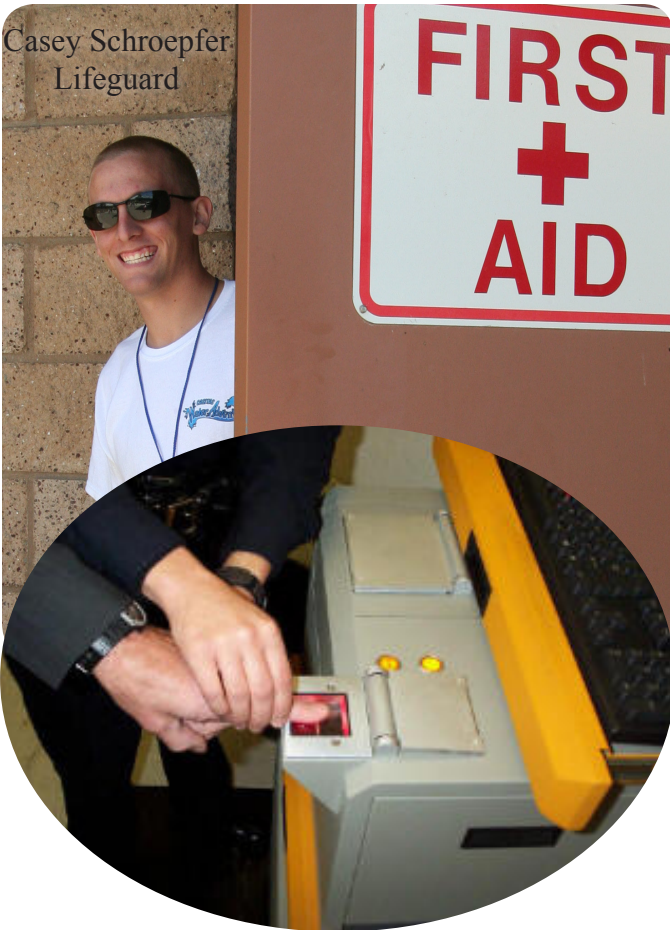
In the spring we set out to give the water play structure a face-lift. The colors were becoming dull and the rubber mats were worn away at the base of each slide. It now has a fresh coat of paint and new landing pads. The vibrant yellow, blue, pink, red and green make the structure an aesthetically pleasing focal point in the park.

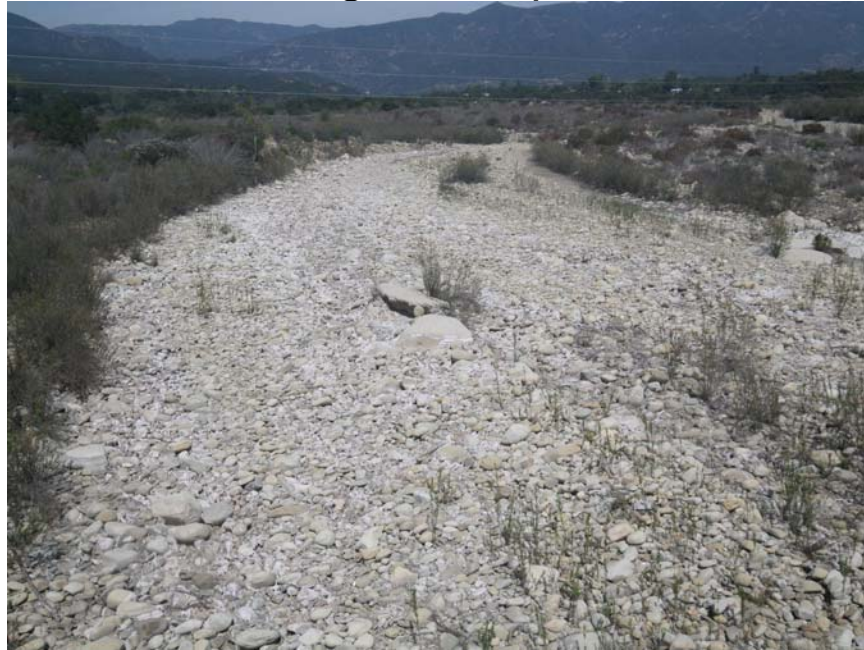
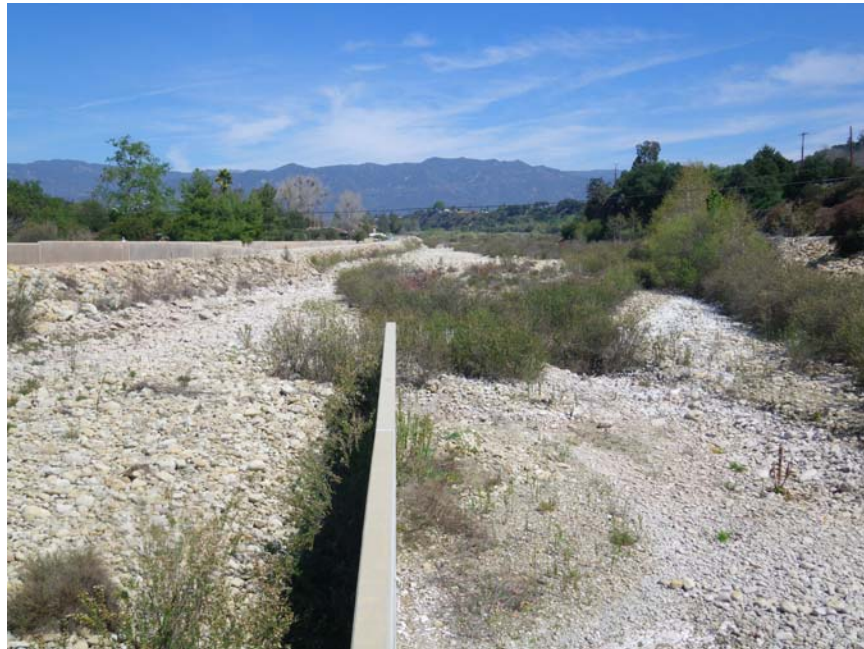
Ventura River channel in the Robles Reach upstream of Hwy 150 (top) and Santa Ana Blvd. (bottom) bridges during March of 2013. Due to low precipitation, the river channel was dry throughout the steelhead migration season.

During 2013, dry conditions prevented data collection for the Upstream Fish Migration Impediment Evaluation. Precipitation in the Ventura Basin was 50-60% of normal for the 2013 water year. Daily mean discharge from the Robles Fish Facility ranged from 0 to 13 cfs. There were several very small rain events during the 2013 water year. However, they were not sufficient to create the runoff and discharge needed to conduct the impediment evaluations. Of the total 15.3 inches of precipitation measured in Matilija Canyon (Ventura County site 207c), about 65% occurred before January 2013.

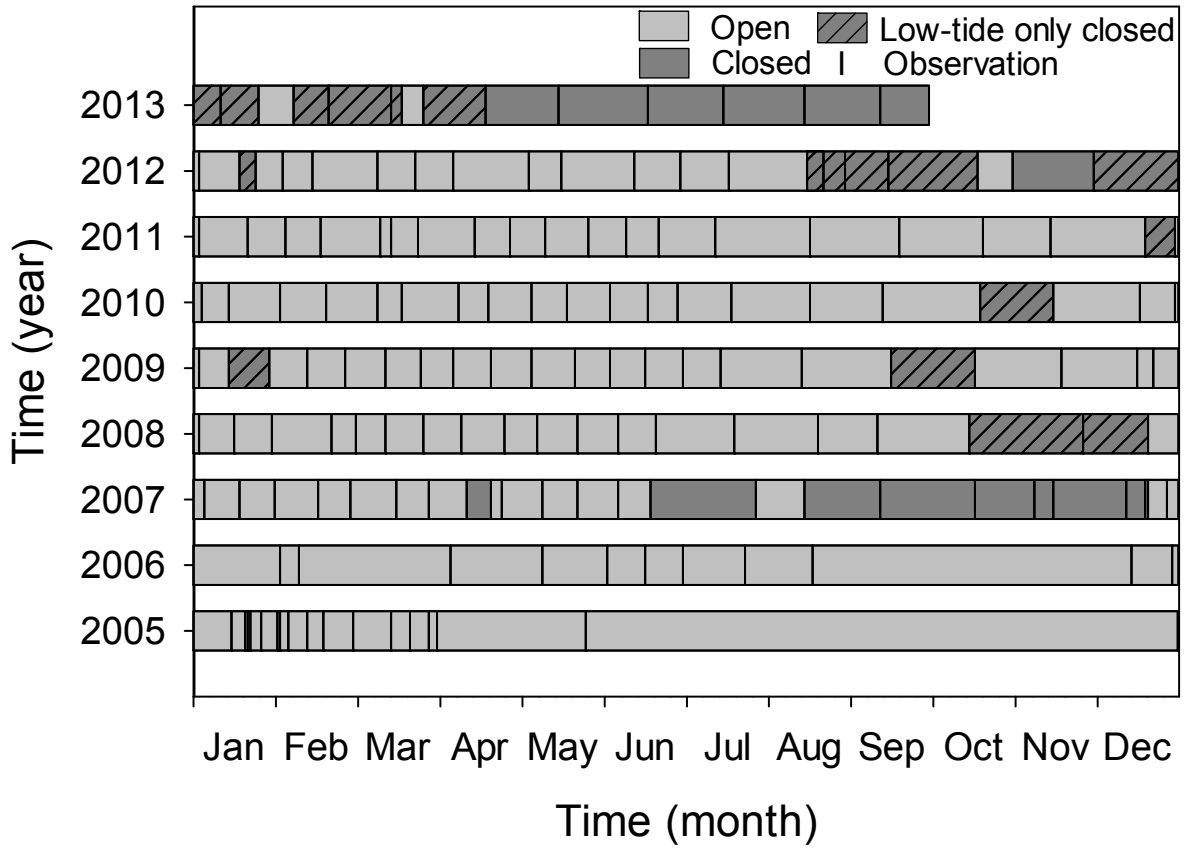
Appendix 4. Sandbar status at the mouth of the Ventura River from 2005 through September of 2013. Each observation is indicated by vertical lines and the sandbar status was assumed to remain in the same until the next observation.

occurred that overtopped the sandbar. However, these overtoppings were not sufficient to erode the sandbar enough to cause water to exit the lagoon. This occurred for 75% of the closed sandbar observations. When the sandbar was open, the period was brief due to low flows that allowed the sandbar to reform quickly. On the days the sandbar was inspected during the reporting period, the mean daily discharge at the USGS Foster Park gage station ranged from < 1 to 5 cfs and 0 to 10.5 cfs at the Robles Fish Facility. When the sandbar was open, the river was observed exiting from the center of the estuary during the reporting period.

and therefore closing the outlet during most years. The status of the sandbar indicates changes in the estuary/lagoon that may help determine potential entry and exit conditions for adult and juvenile steelhead. It appears that passage conditions remain suitable during most seasons when steelhead are likely migrating. However, lagoon conditions optimal for juvenile rearing (i.e., when a sandbar closes and results in an estuary forming a deeper freshwater lagoon; Bond et al. 2008), appear to have been limited during the study period beginning in 2005. The two consecutive years of below-normal precipitation (both about 50-60% of average) have created conditions at the mouth of the Ventura River causing the sandbar to be closed for the majority of the time during the monitoring period. This has occurred even though some surface water has continued to flow into the lagoon (approximately 2-3 cfs during August of 2013). Furthermore, the amount of time the sandbar was closed over this reporting period was the greatest since monitoring began in 2005.

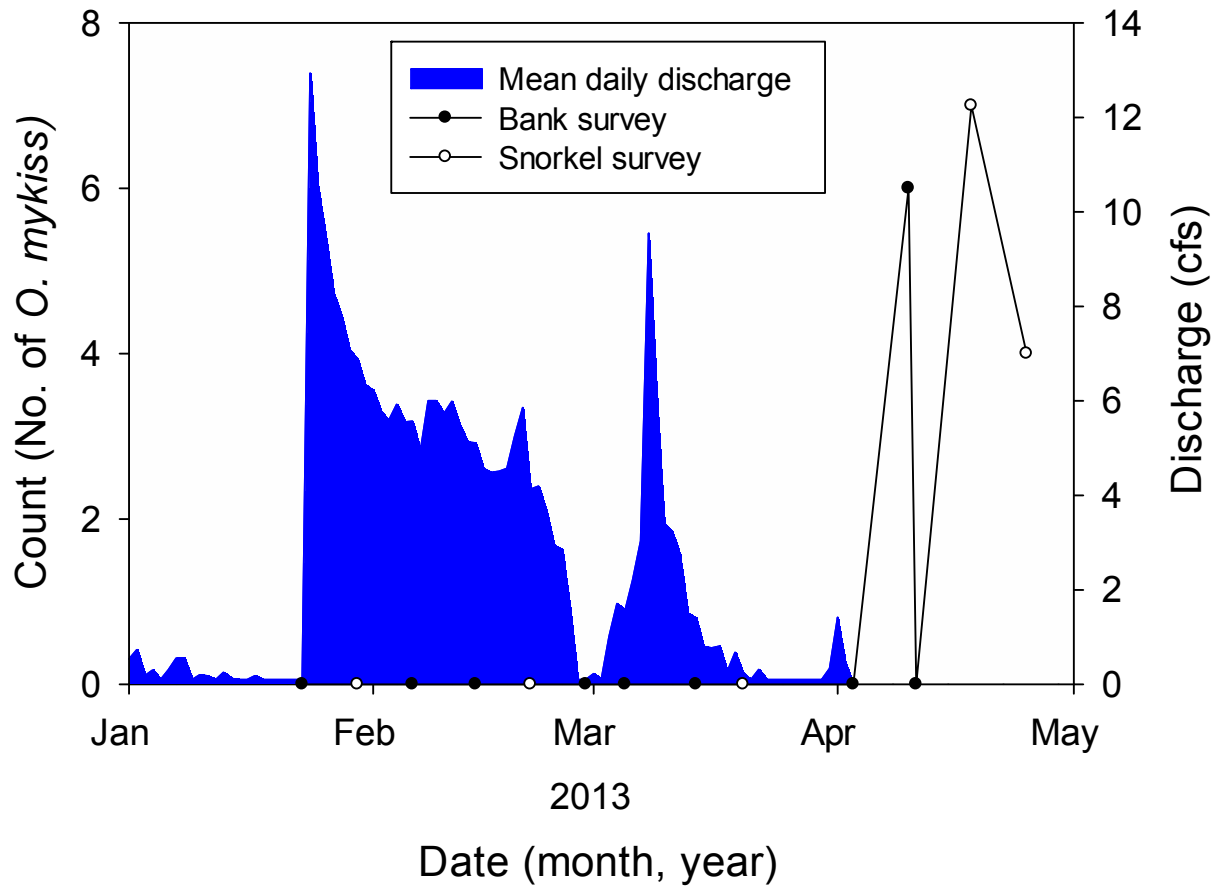
Appendix 6. Total count of *O. mykiss* observed during fish attraction surveys during the fish passage season from January through April 2013 at the Robles Facility.

A total of 17 *O. mykiss* were counted from January through April of 2013 in the entire 340 m study reach (Appendix 5), which covered the upstream and downstream reaches. During the 4-month period, a total of 4,220 m were surveyed by either bank or snorkel methods. The water temperatures during the study period ranged from 10 °C in January to 18 °C in April and turbidity was less than 2 NTUs when the surveys were conducted. *O. mykiss* were observed only during April of the survey period and peaked at 7 fish. The discharge at the Robles Fish Facility ranged from 0 to 13 cfs at the time of the surveys. Flowing water remained in the upper portions of the survey reach (<1 cfs) even though no flow was passing over the weir at times before the entire survey reach went dry.

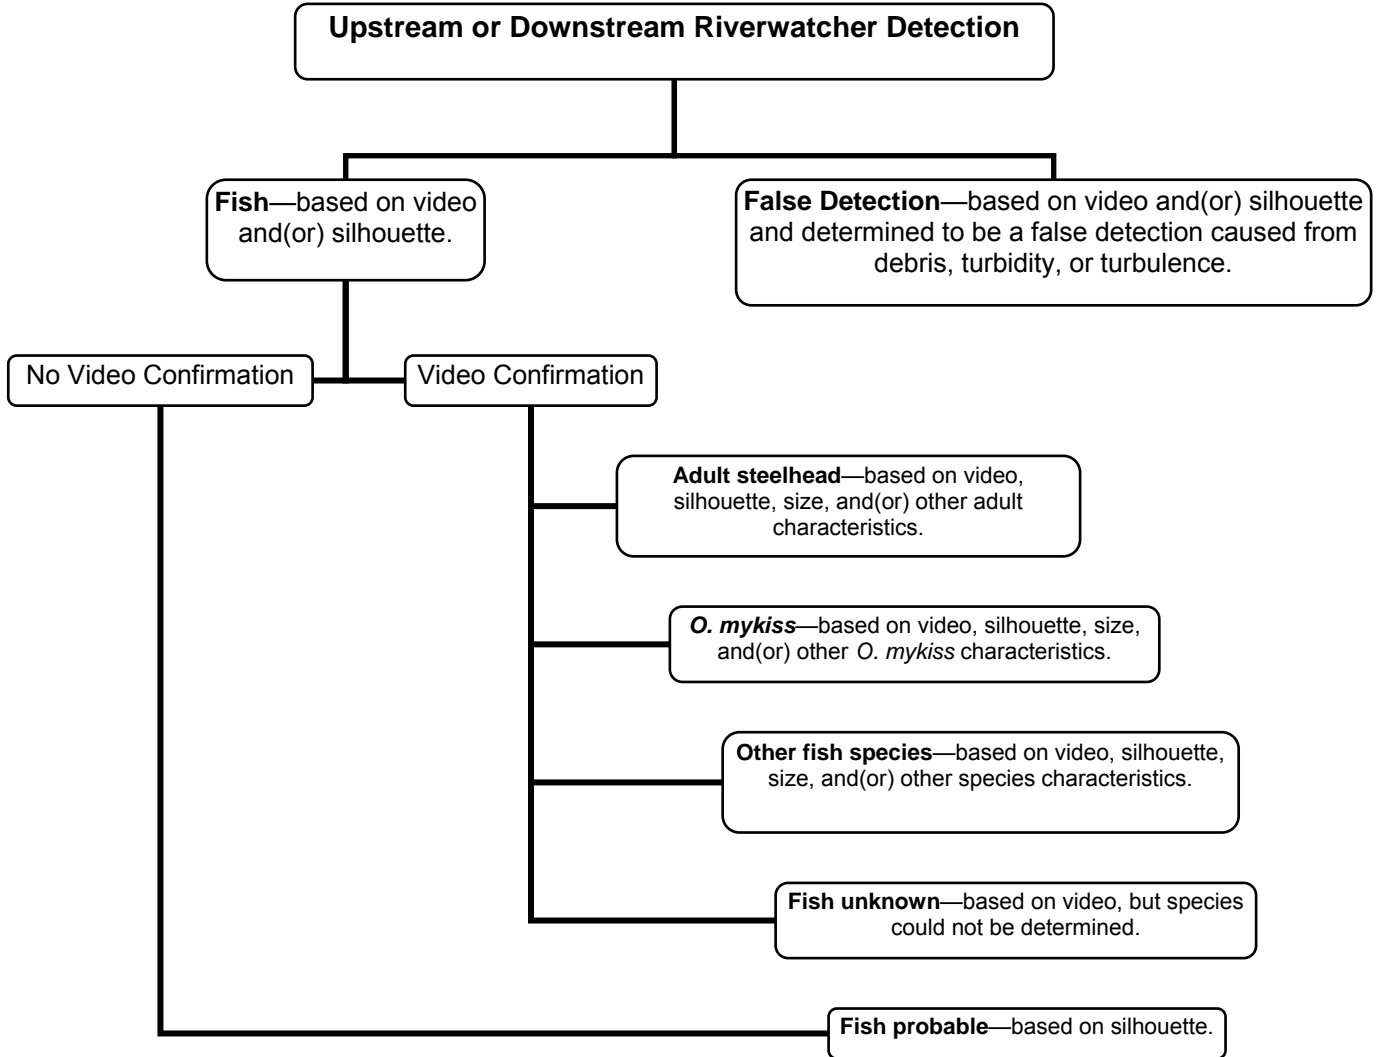
Appendix 7. Riverwatcher detection classification flow chart that outlines the pathways for upstream and downstream detections.

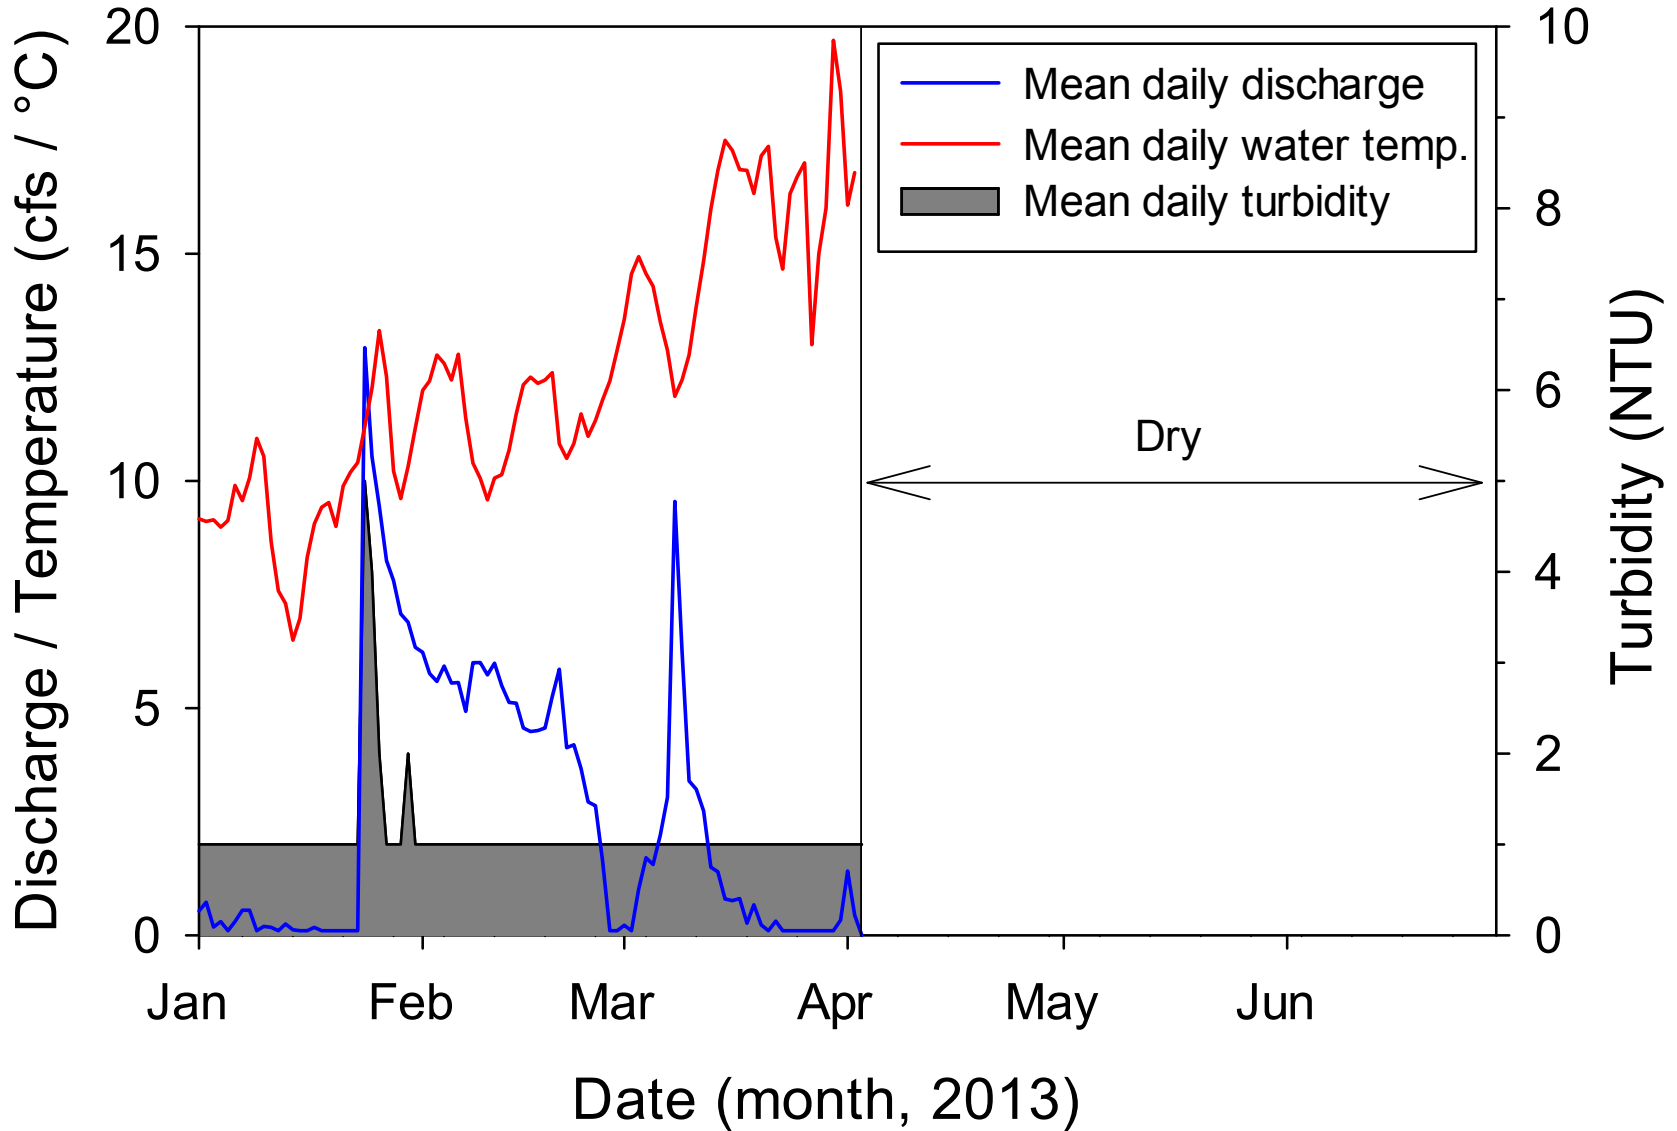
Appendix 11. Mean daily discharge, water temperature, and turbidity from the Robles Fish Facility during the 2013 fish passage season.

The physical river conditions of temperature, turbidity, and discharge were similar at the time of fish detections since they occurred on the same day (Appendix 9). The mean water temperature recorded during the time migrating fish were detected was approximately 13 °C. The mean turbidity levels at the time of passage was about 1 NTU. The discharge from the Robles Fish Facility at the time of passage was 0.0 cfs. This was recorded at the measurement weir but there was still nominal flow through the ladder.

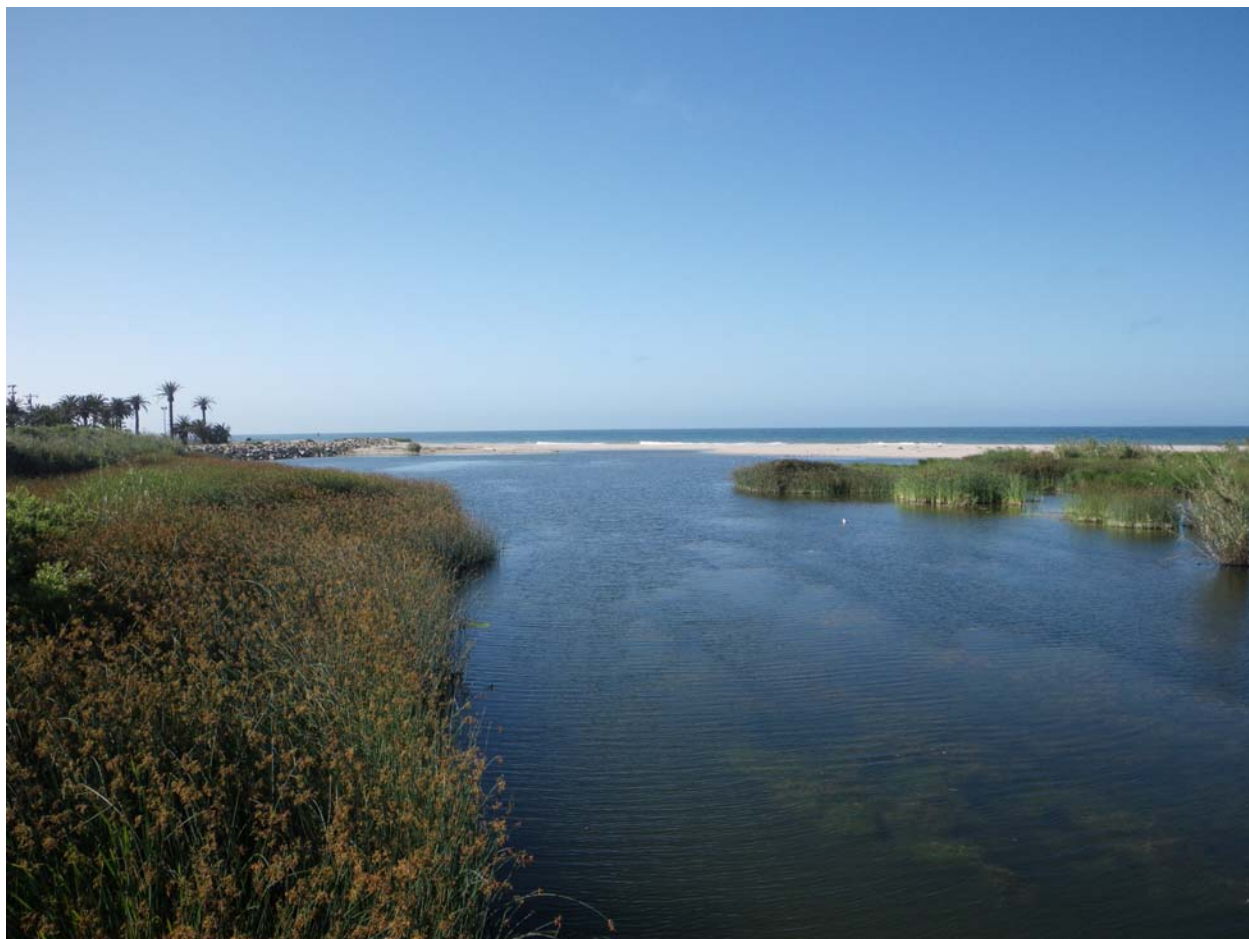
Photo of the Ventura River lagoon on 18 June 2013 with the sandbar closed. During the previous 12-months, the sandbar was closed approximately 88% of the time and represented the longest period of significant bar formation since monitoring began in 2005.

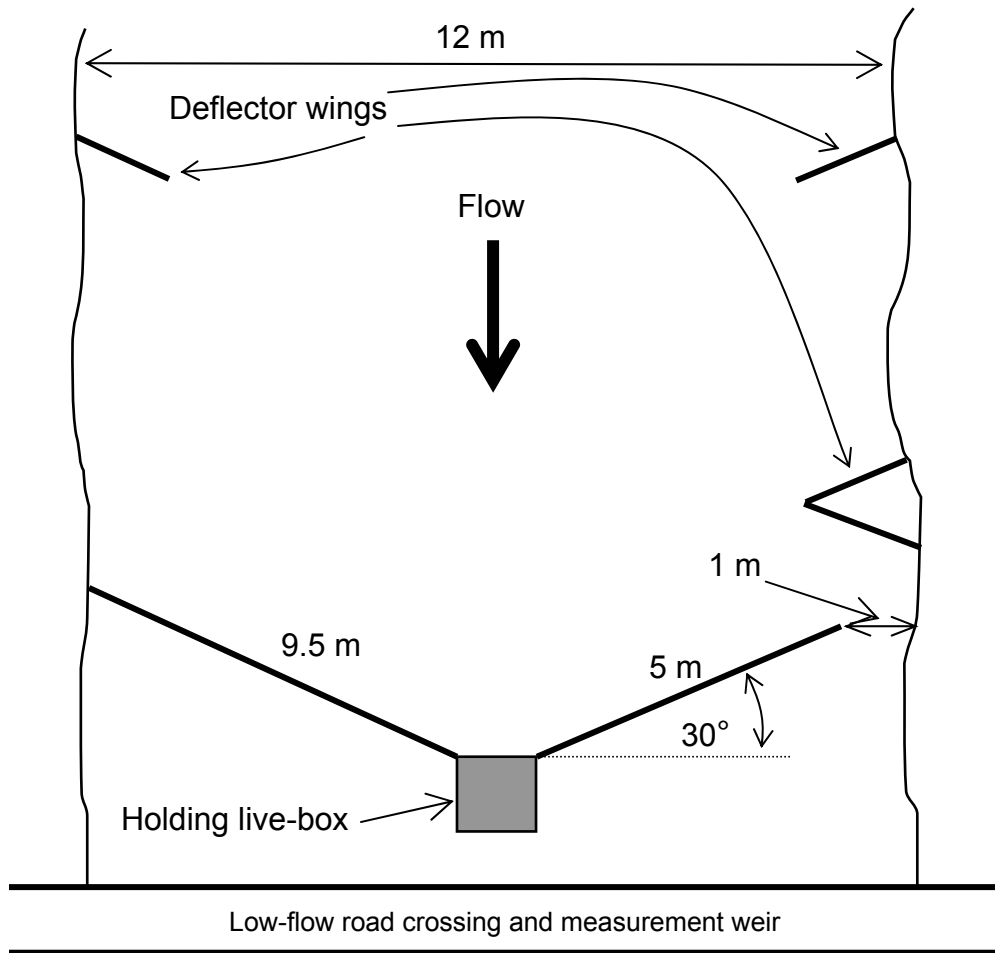
Figure 2. Top view of downstream migrant smolt trap layout in the Ventura River below the Robles Fish Facility.

Since the vast majority of downstream steelhead migrants are expected to be captured from mid-March through mid-June (Shapovalov and Taft 1954; Dettman and Kelley 1986), the trap will be operated from mid-March through June or until water temperatures exceeded a daily mean of 22°C, which could negatively impact captured fish (SYRTAC 1999). In addition, if the surface water connection in the Robles Reach is lost during the trapping period, the trap will not be operated.

The trap is intended to be operated only at lower river flows when it would be effective at capturing downstream migrants. The upper limit of river flow operation will be determined after the first year of operation when flow conditions exist. Because base flow conditions are more likely to be used for downstream passage by steelhead (NMFS 2003), a weir trap was chosen for this evaluation.

When the trap is operational, it will be checked twice per day (in the morning and late afternoon). During 2009, 95% of the downstream migrating *O. mykiss* were detected by the Riverwatcher in the morning from 02:00-06:00 h (CMWD 2009). Data to be collected will include: fork length (mm), weight (g), and a subsample of scale and tissue samples for aging and genetic analysis. Fish that are to be handled will be put into an aerated container with a solution of tricaine methanesulfonate (MS-222) and Stress Coat[®]. The anesthesia MS-222 is registered by the US Food and Drug Administration for use with food fish (Summerfelt and Smith 1990). The level of anesthesia needed is generally stage 2-4, which is a deep sedation to a total loss of equilibrium (Summerfelt and Smith 1990). To achieve a short induction time of 3-4 minutes, as recommended by Summerfelt and Smith (1990), a concentration of 60-100 mg/L of MS-222 will be

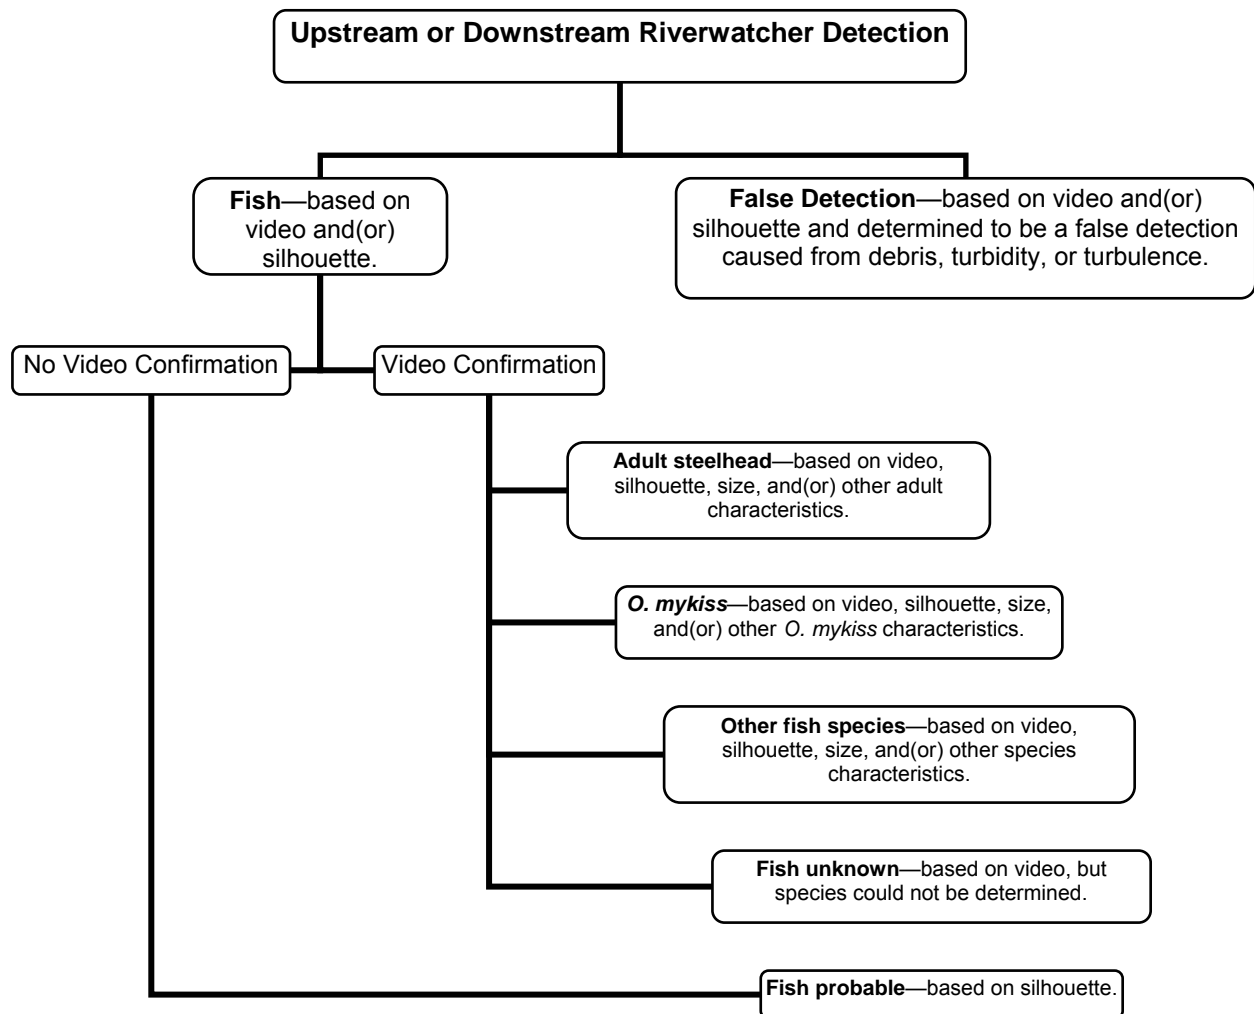
Figure 3. Riverwatcher detection classification flow chart that outlines the pathways to classifying upstream and downstream detections.

Prior to 2010, each upstream and downstream Riverwatcher detection was reviewed and classified as an adult steelhead, *O. mykiss* non-adult steelhead, other species if fish are identifiable, fish unknown, fish probable, or false detection (Figure 3). At the request of NMFS, this classification system was modified during the review process of the 2010 report. All confirmed *O. mykiss* will be classified solely as *O. mykiss*. The classifications will be determined by using the combination of silhouette images, estimated lengths, and video clips. In addition, if larger adult sized *O. mykiss* are detected, a measurement of eye diameter and standard length (SL) will be estimated from the video clip to calculate morphometric ratios that will be compared to known steelhead and rainbow trout. A commonly used method is to develop ratios of body measurements for comparison so that the effects of body size can be removed and actual differences can be determined (Strauss and Bond 1990).

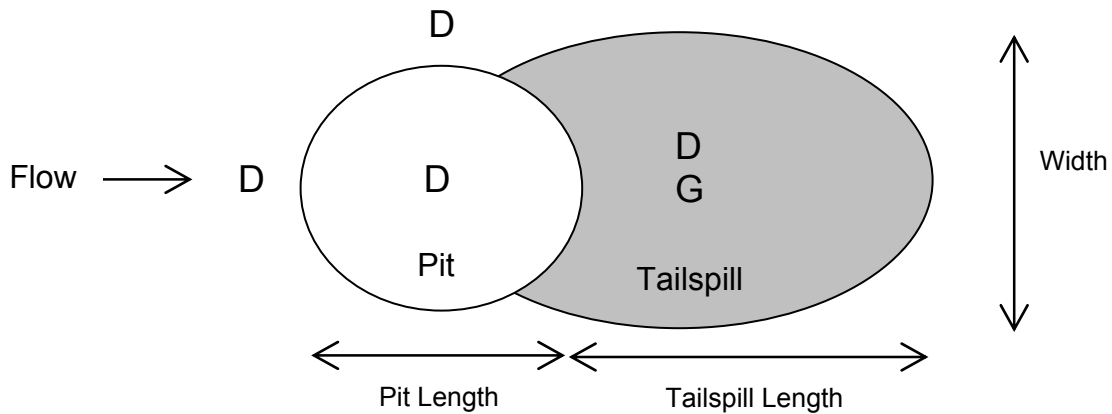
Figure 4. Diagram of measurements to be collect on all identified *O. mykiss* redds. (D) = locations of depth measurements and (G) = location of gravel substrate sampling.
