2014 Robles Fish Passage Facility Progress Report

Casitas Municipal Water District
1055 Ventura Avenue
Oak View, California 93022

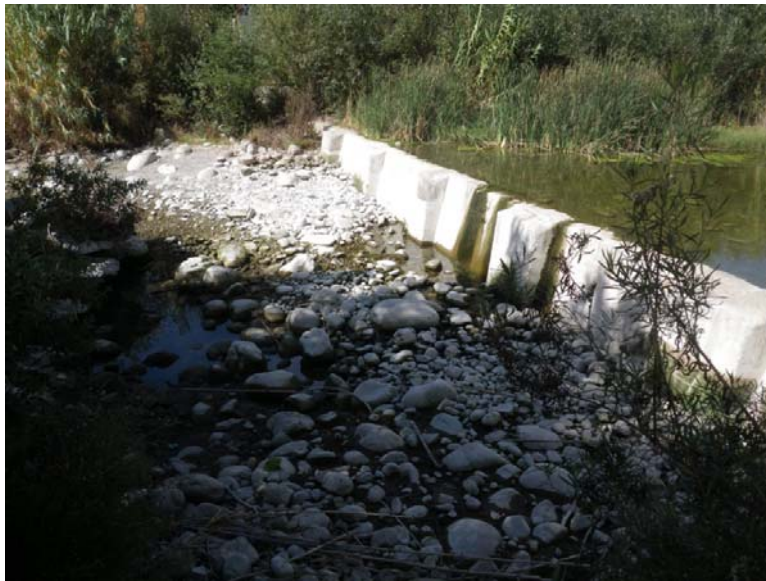
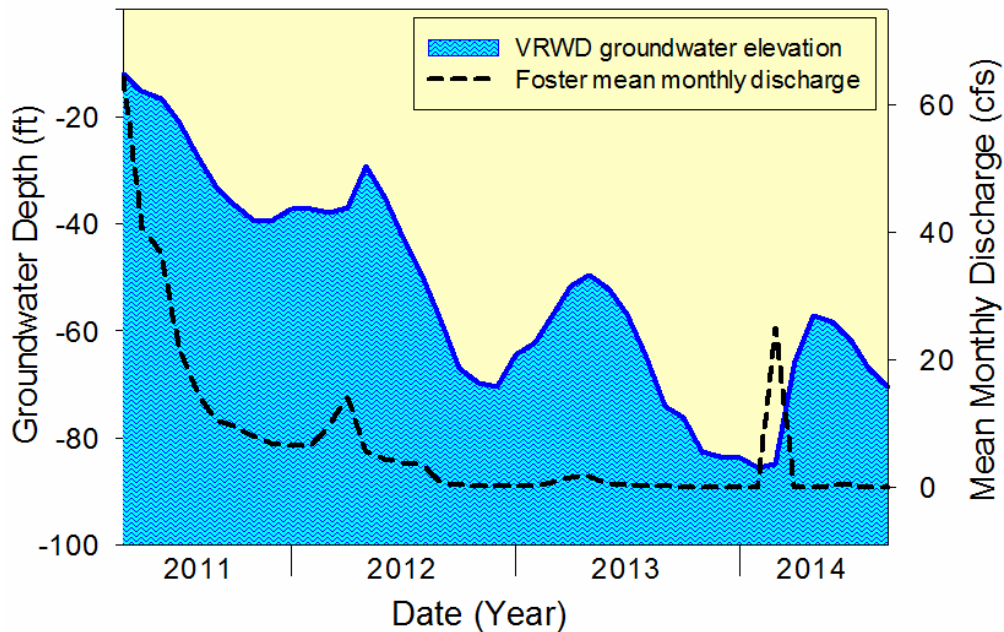
Ventura River channel going subsurface at Foster Park in 2012 for the first time in several years (top) Mean monthly discharge at Foster Park (USGS) and groundwater elevation near HWY 150 bridge (VRWD) since April 2011 (bottom). Three consecutive years of below average precipitation have resulted in groundwater depletion in the Ventura River basin and limited surface connection to only 72 hours during the 2014 fish passage season.

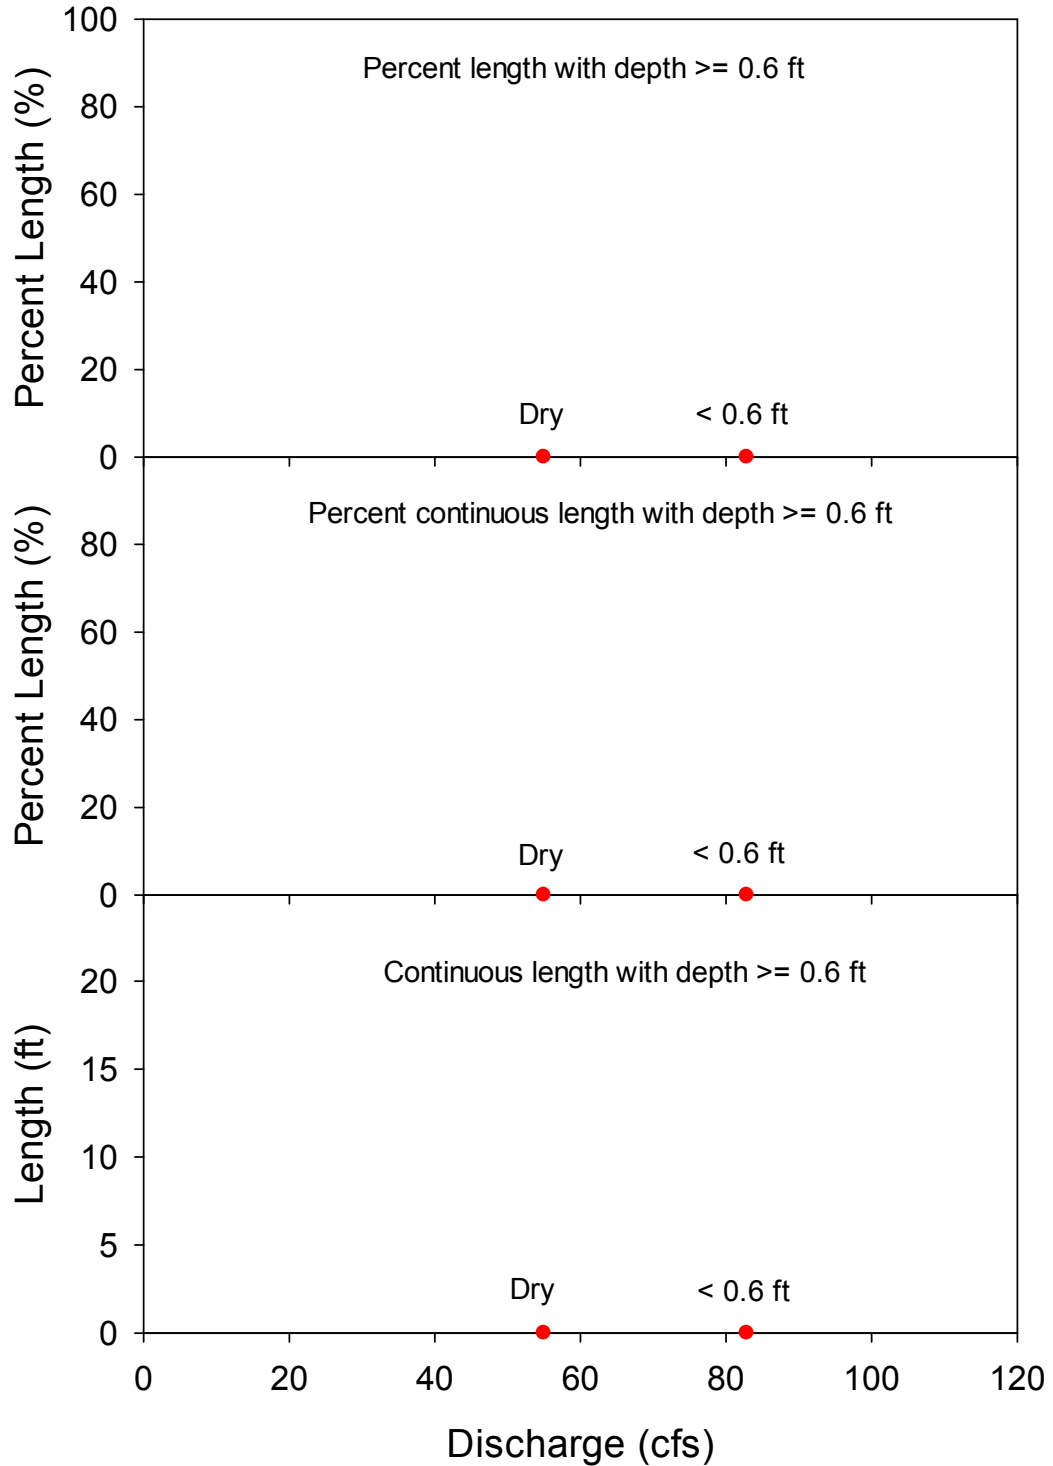
Appendix 3. Relation between Robles discharge and water depth at Site 10 downstream of Casitas Springs during 2014.

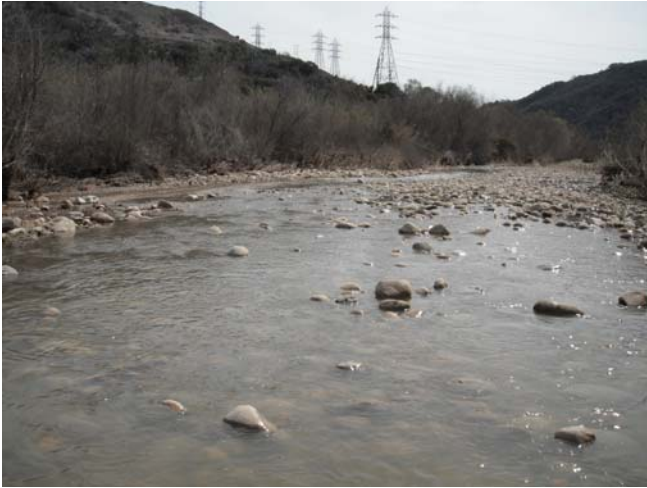
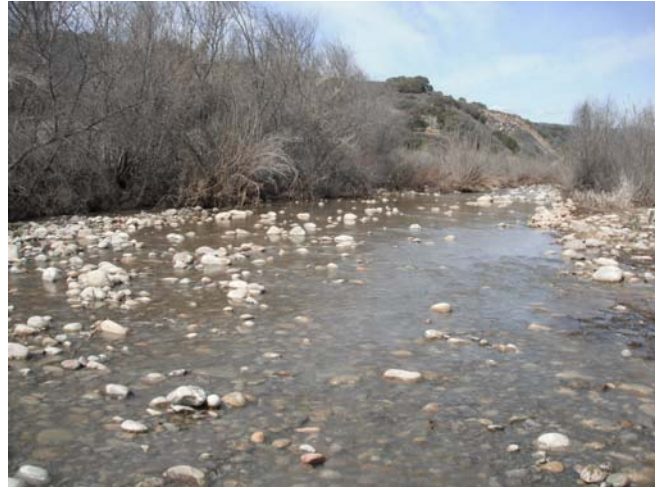
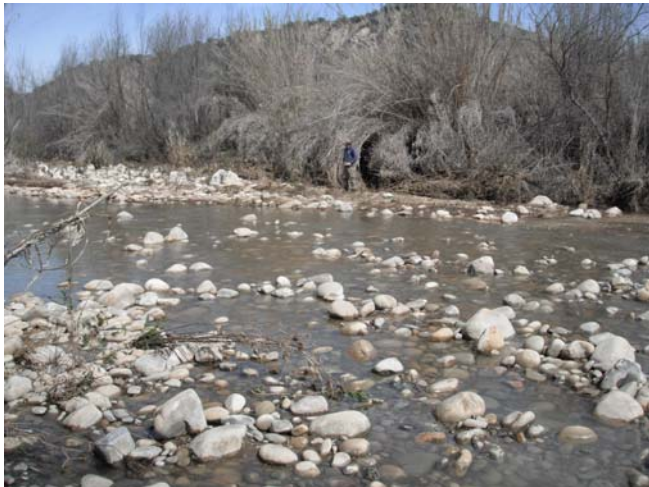
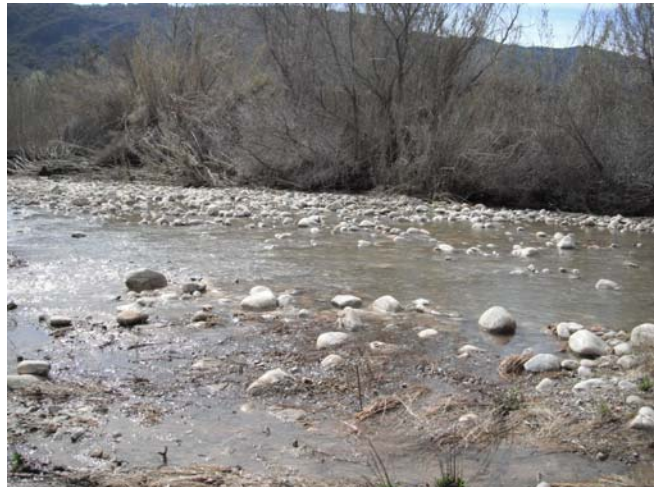
Appendix 12a. Photos of Site 10 impediment on 03 March 2014 during 83 cfs discharge release from Robles Fish Facility, looking: (A) downstream, (B) upstream, (C) right to left bank, and (D) left to right bank.

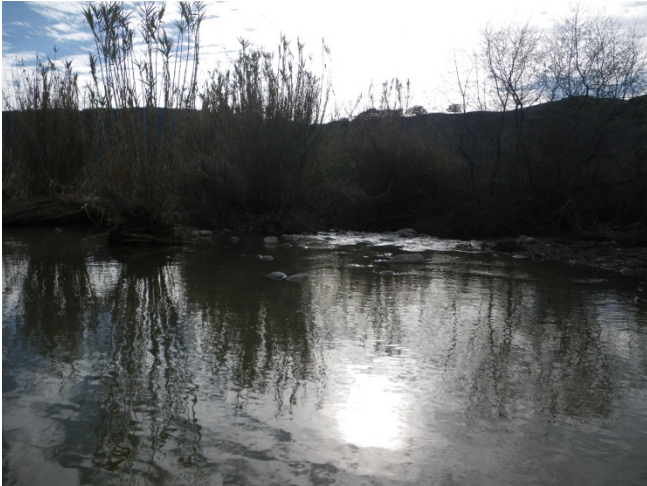
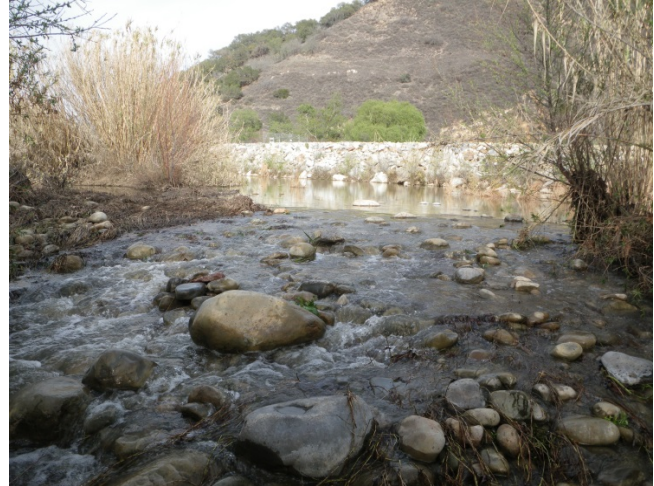
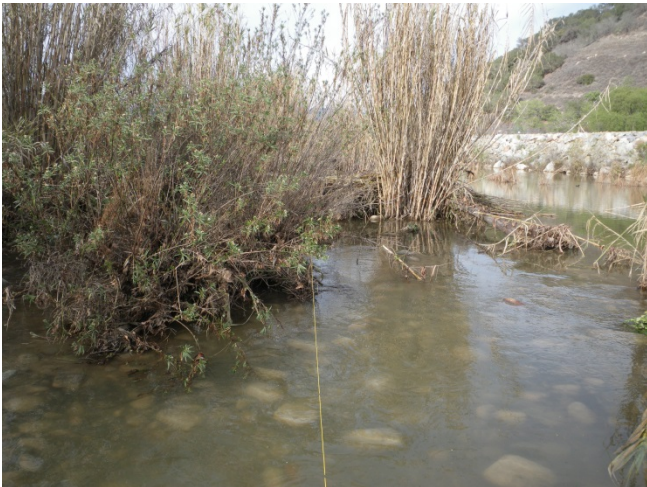
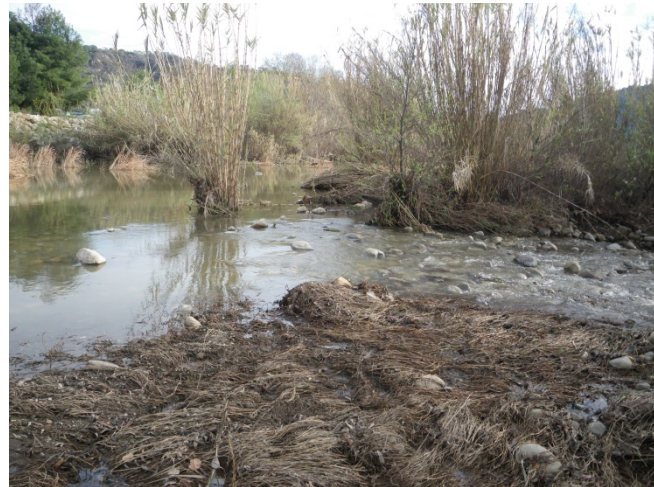
Appendix 12b. Photos of Site 3-2 impediment on 03 March 2014 during 82 cfs discharge release from Robles Fish Facility, looking from: (A) downstream, (B) upstream, (C) right to left bank, and (D) left to right bank.

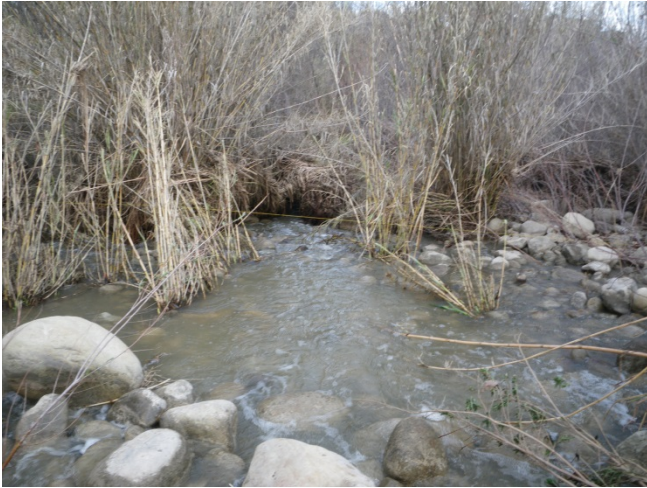
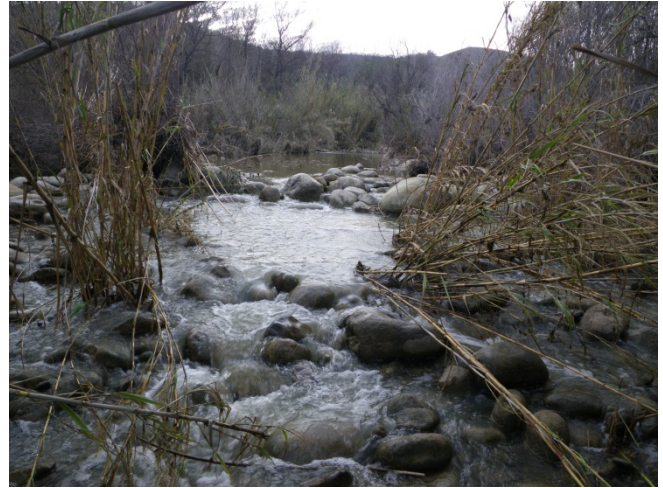
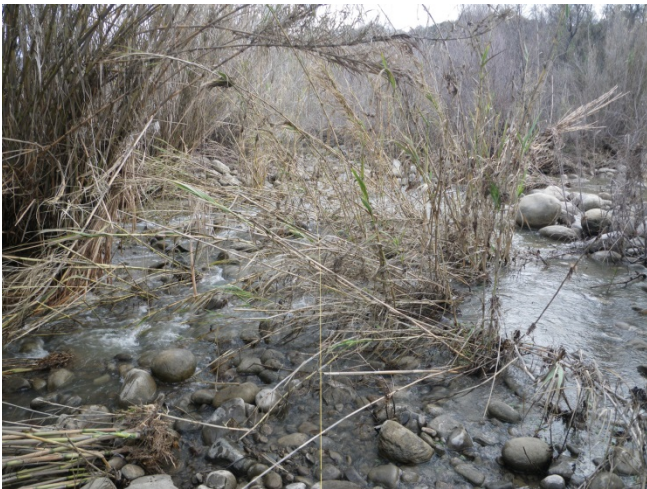
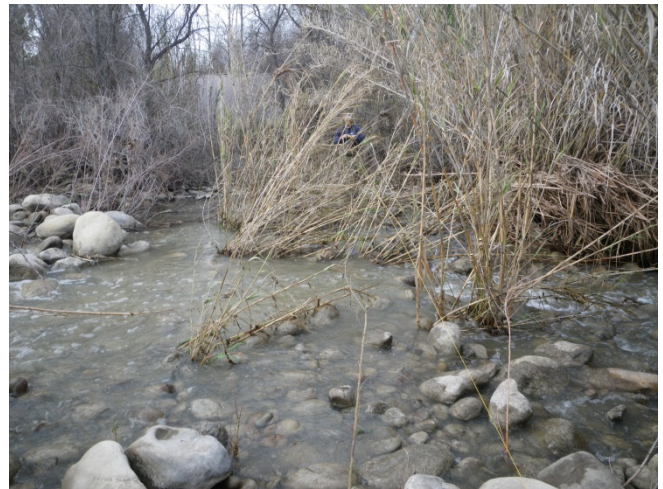
Appendix 12c. Photos of Site 4 impediment on 03 March 2014 during 79 cfs discharge release from Robles Fish Facility, looking from: (A) downstream, (B) upstream, (C) right to left bank, and (D) left to right bank.

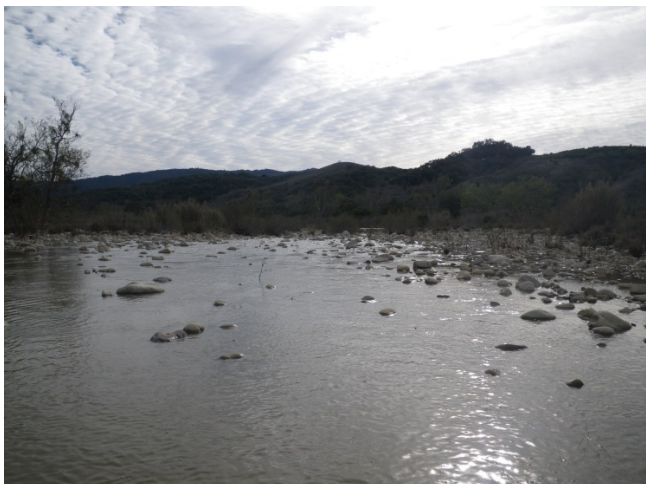
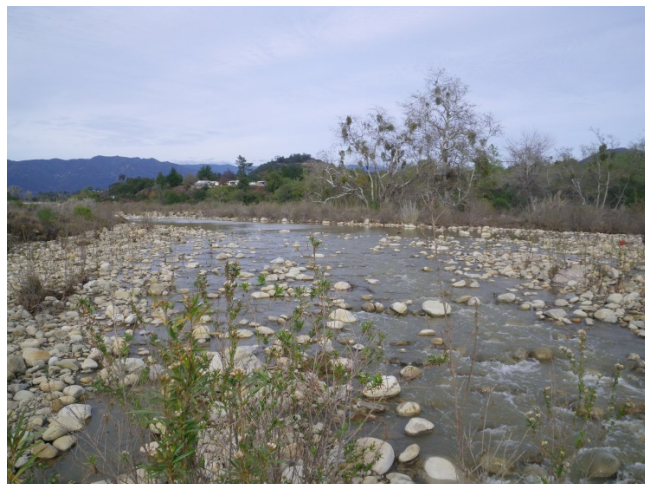
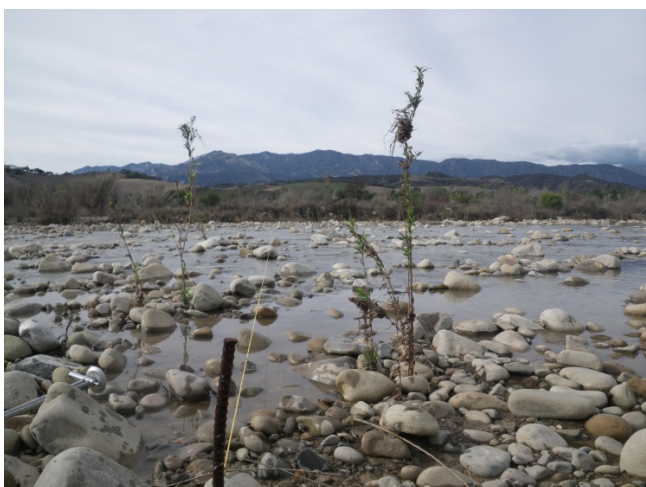
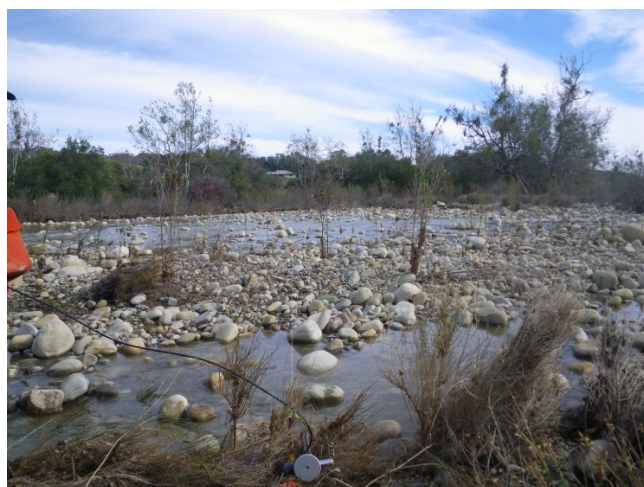
Appendix 12d. Photos of Site 5-2 impediment on 03 March 2014 during 77 cfs discharge release from Robles Fish Facility, looking from: (A) downstream, (B) upstream, (C) right to left bank, and (D) left to right bank.

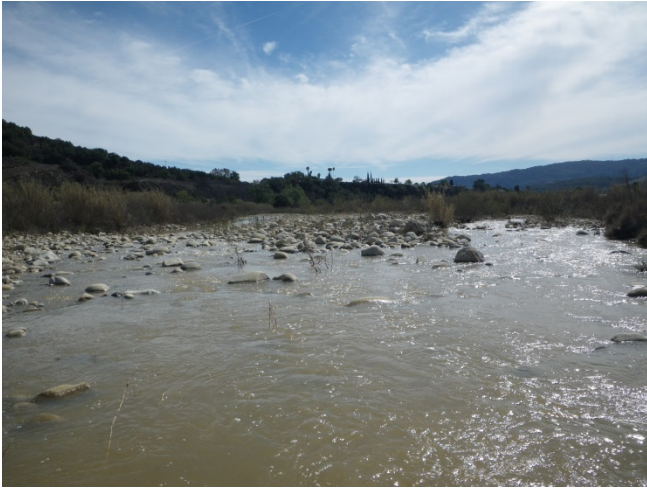
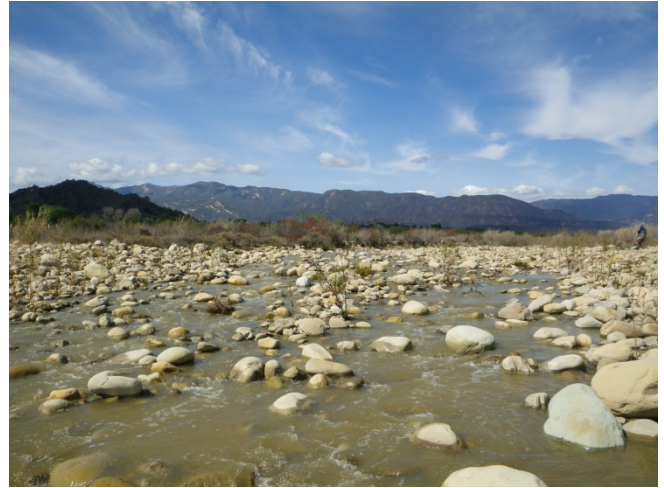
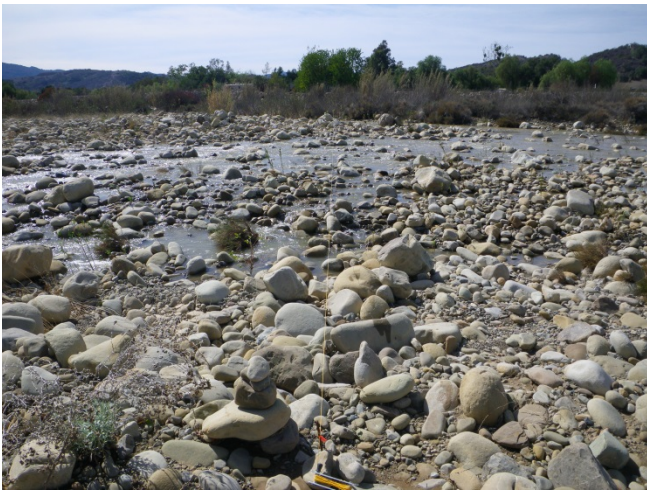
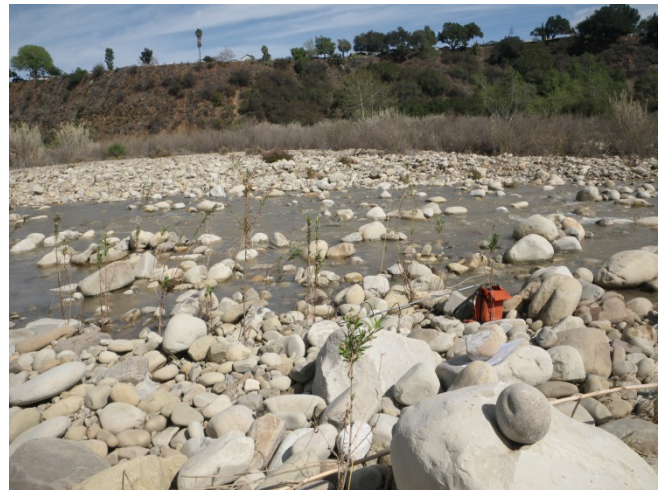
Appendix 12e. Photos of Site 6-2 impediment on 03 March 2014 during 78 cfs discharge release from Robles Fish Facility, looking from: (A) downstream, (B) upstream, (C) right to left bank, and (D) left to right bank.

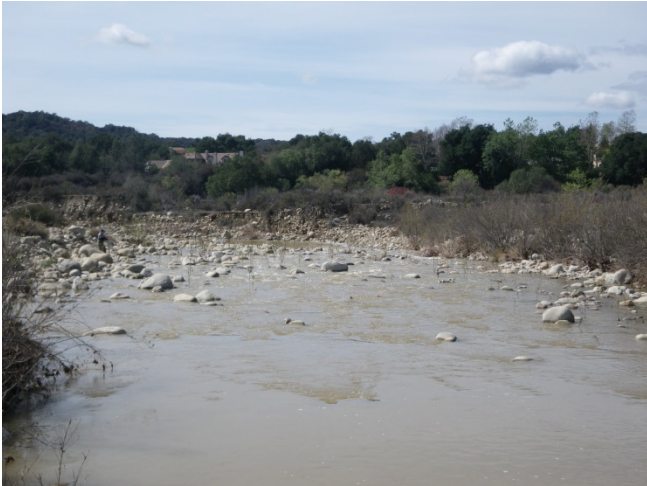
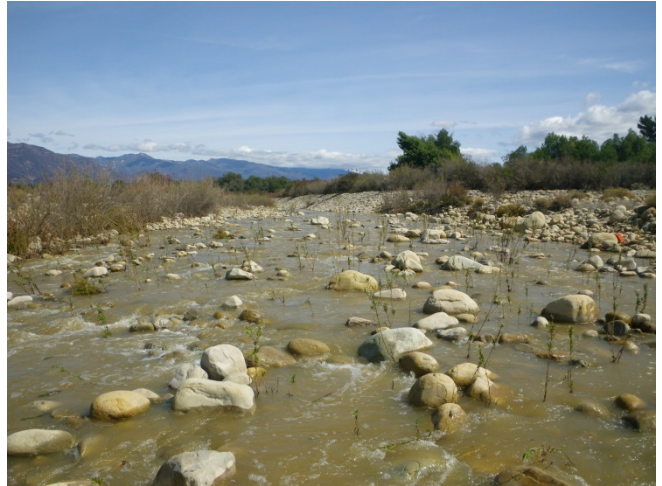
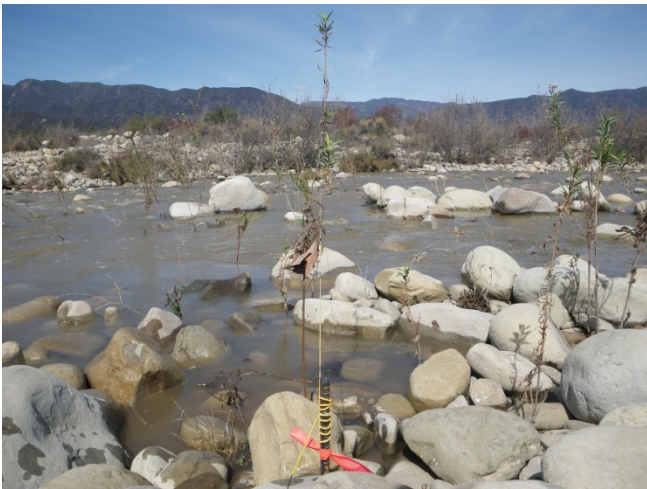
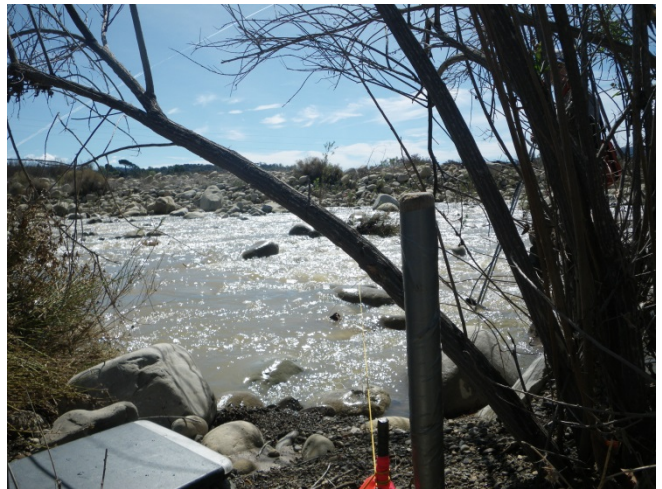
Appendix 12f. Photos of Site 9 impediment on 03 March 2014 during 78 cfs discharge release from Robles Fish Facility, looking: (A) downstream, (B) upstream, (C) right to left bank, and (D) left to right bank.

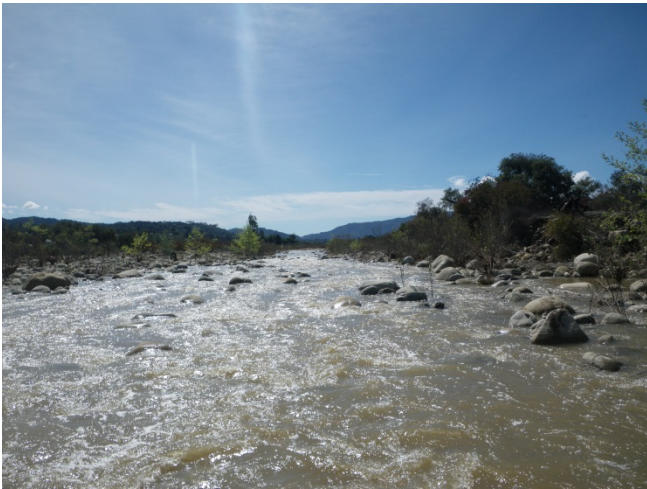
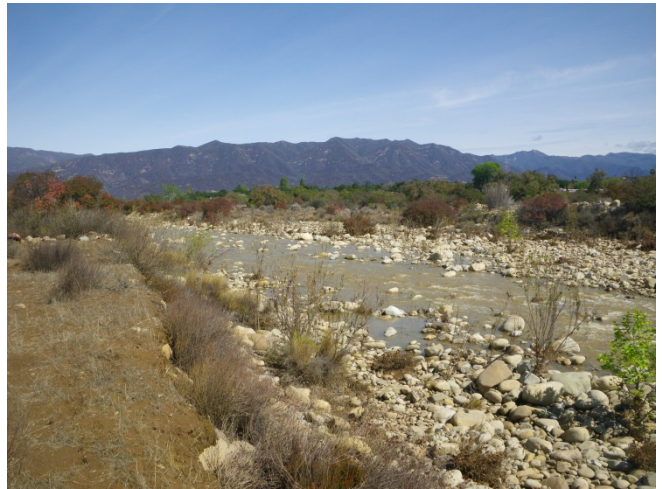
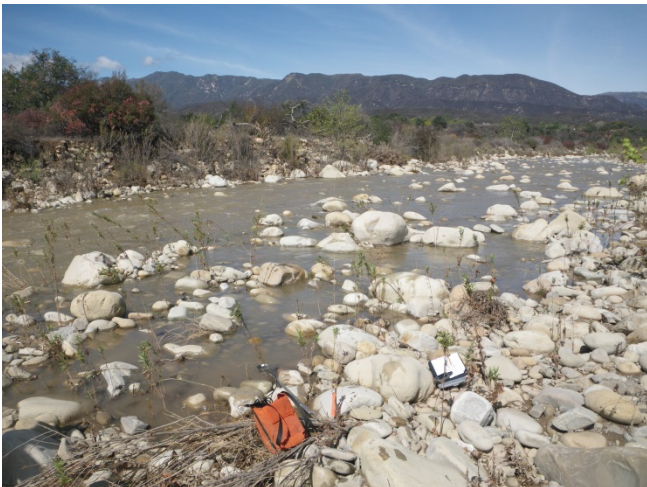
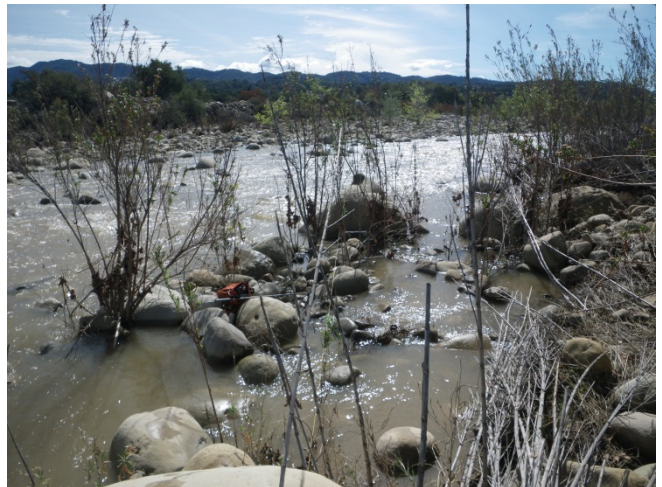
Appendix 12g. Photos of Site 7 impediment on 03 March 2014 during 80 cfs discharge release from Robles Fish Facility, looking from: (A) downstream, (B) upstream, (C) right to left bank, and (D) left to

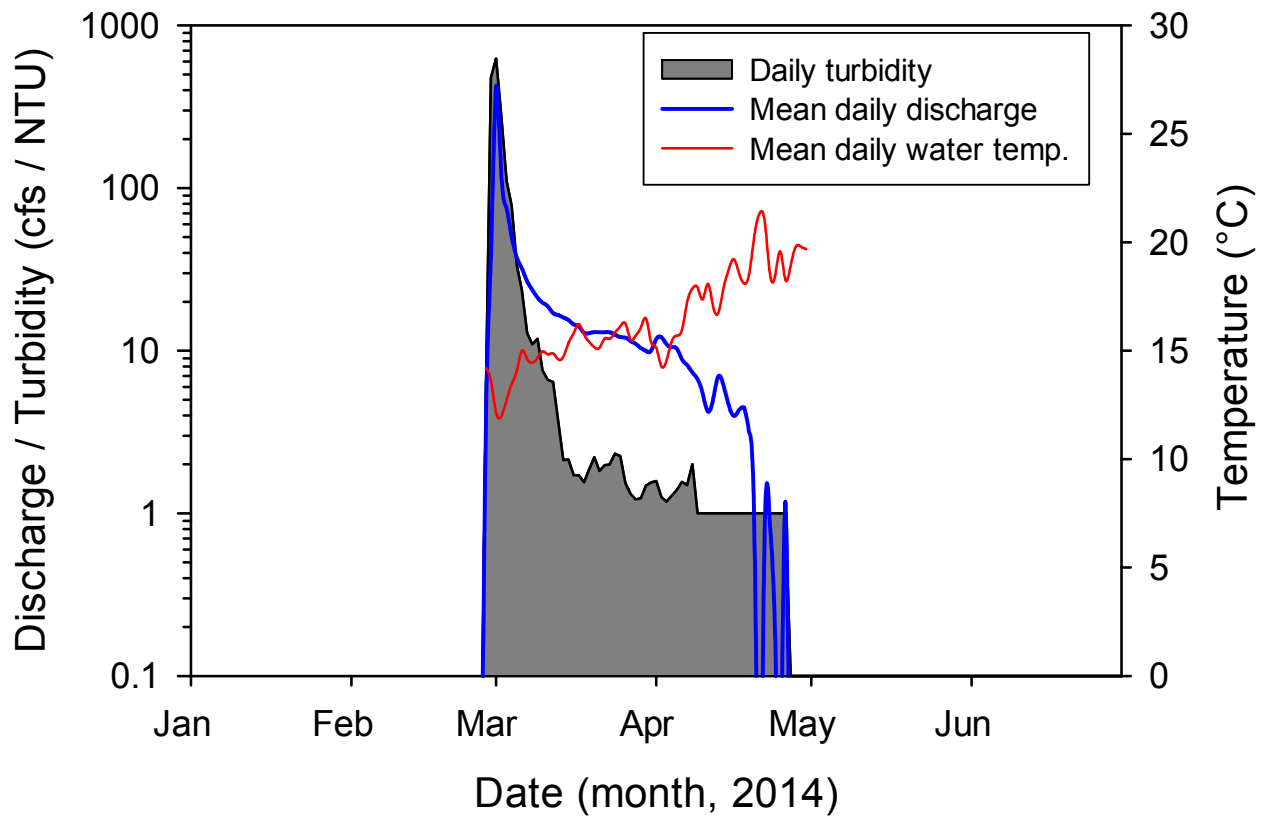
Appendix 19. Mean daily discharge, water temperature, and turbidity at the Robles Fish Facility during the 2014 fish passage season.

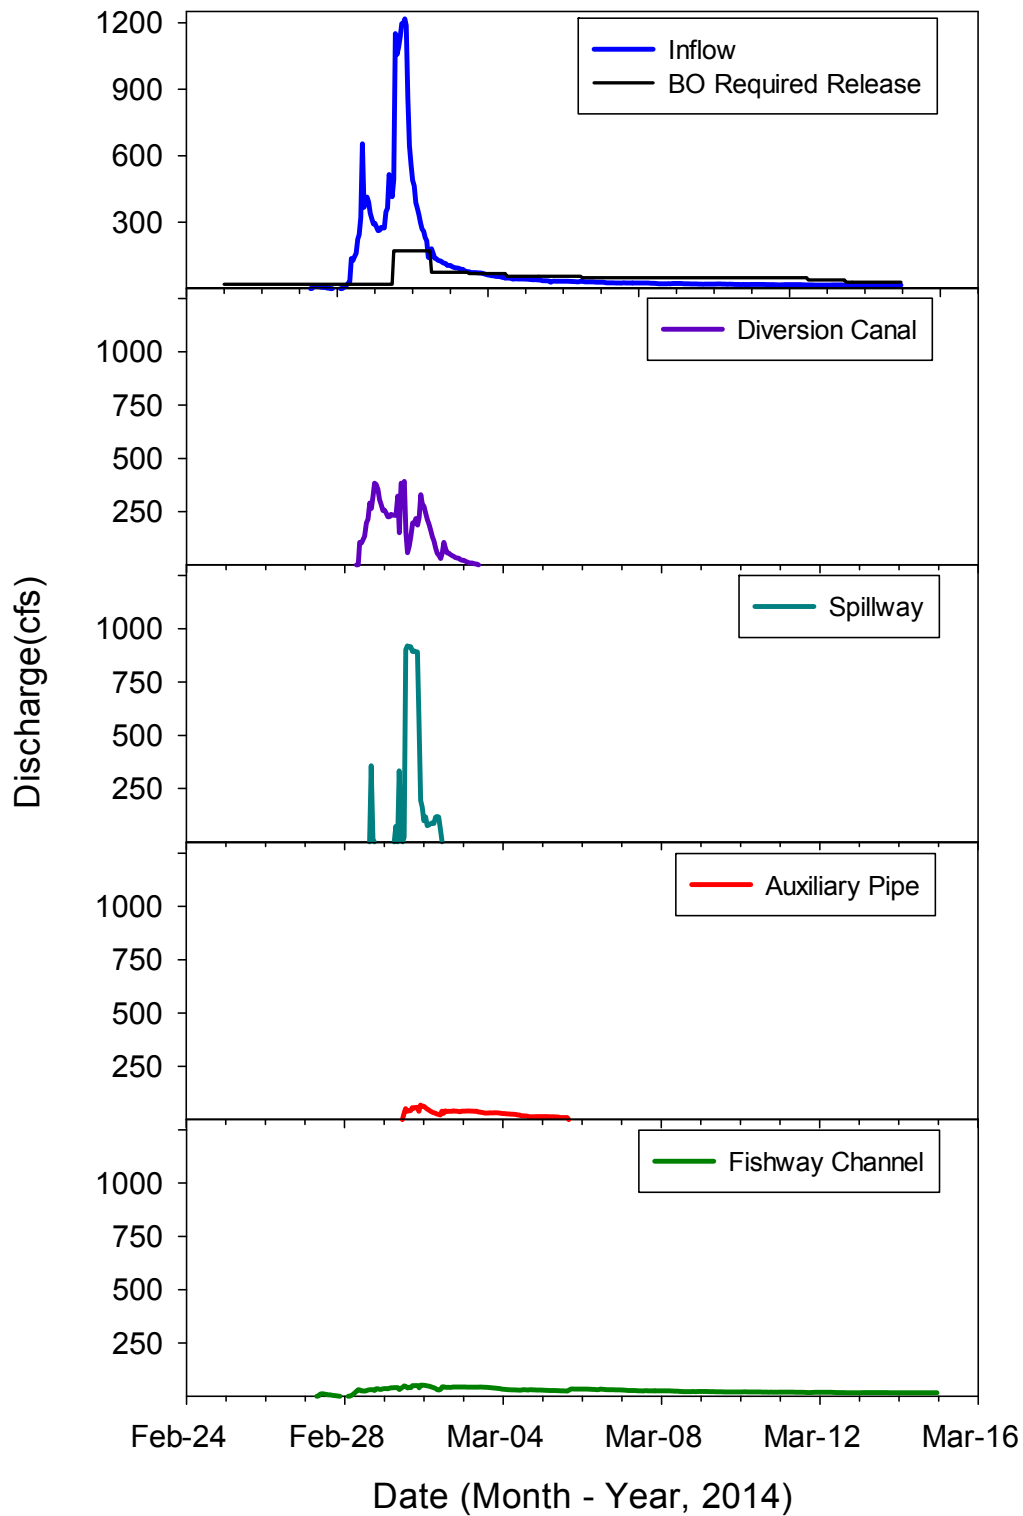
Appendix 20. Mean hourly discharge of inflow, diversion, spillway, auxiliary, and fishway at the Robles Fish Facility during the 01 March 2014 storm event.

All of the instruments can suffer from inaccuracies from time to time. The inaccuracies can be caused by clogging of bubbler lines, electronic creep, debris accumulating on sensors, changes to the measured cross sections, human interactions and equipment problems. For this reason, the data is verified against field measurements and observations. The information gathered from each of these locations has been reduced to the mean daily flows in cfs (Appendix 18). The mean daily Robles Fish Facility discharge and corresponding turbidity and temperature measurements for the entire Fish Passage Season are presented in Appendix 19. Also included are the mean hourly flow data for the three days preceding the peak and for the twelve days following the peak (Appendix 20).

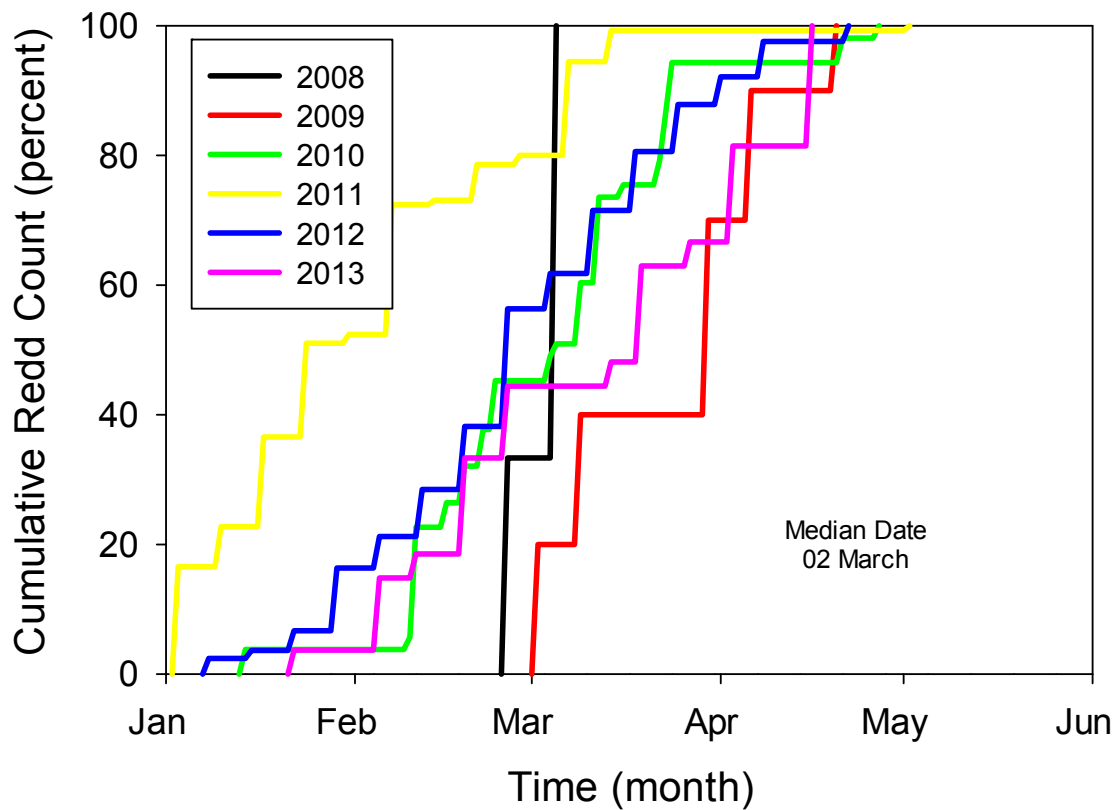
Appendix 29. Cumulative spawning distributions from 2008 through 2013 spawning years at index sites. Median spawning date for 6-year sampling period was 02 March.
