**CONDITION BASED
ASSESSMENT & WATER
MASTER PLAN**

for
Casitas Municipal
Water District

October 2018

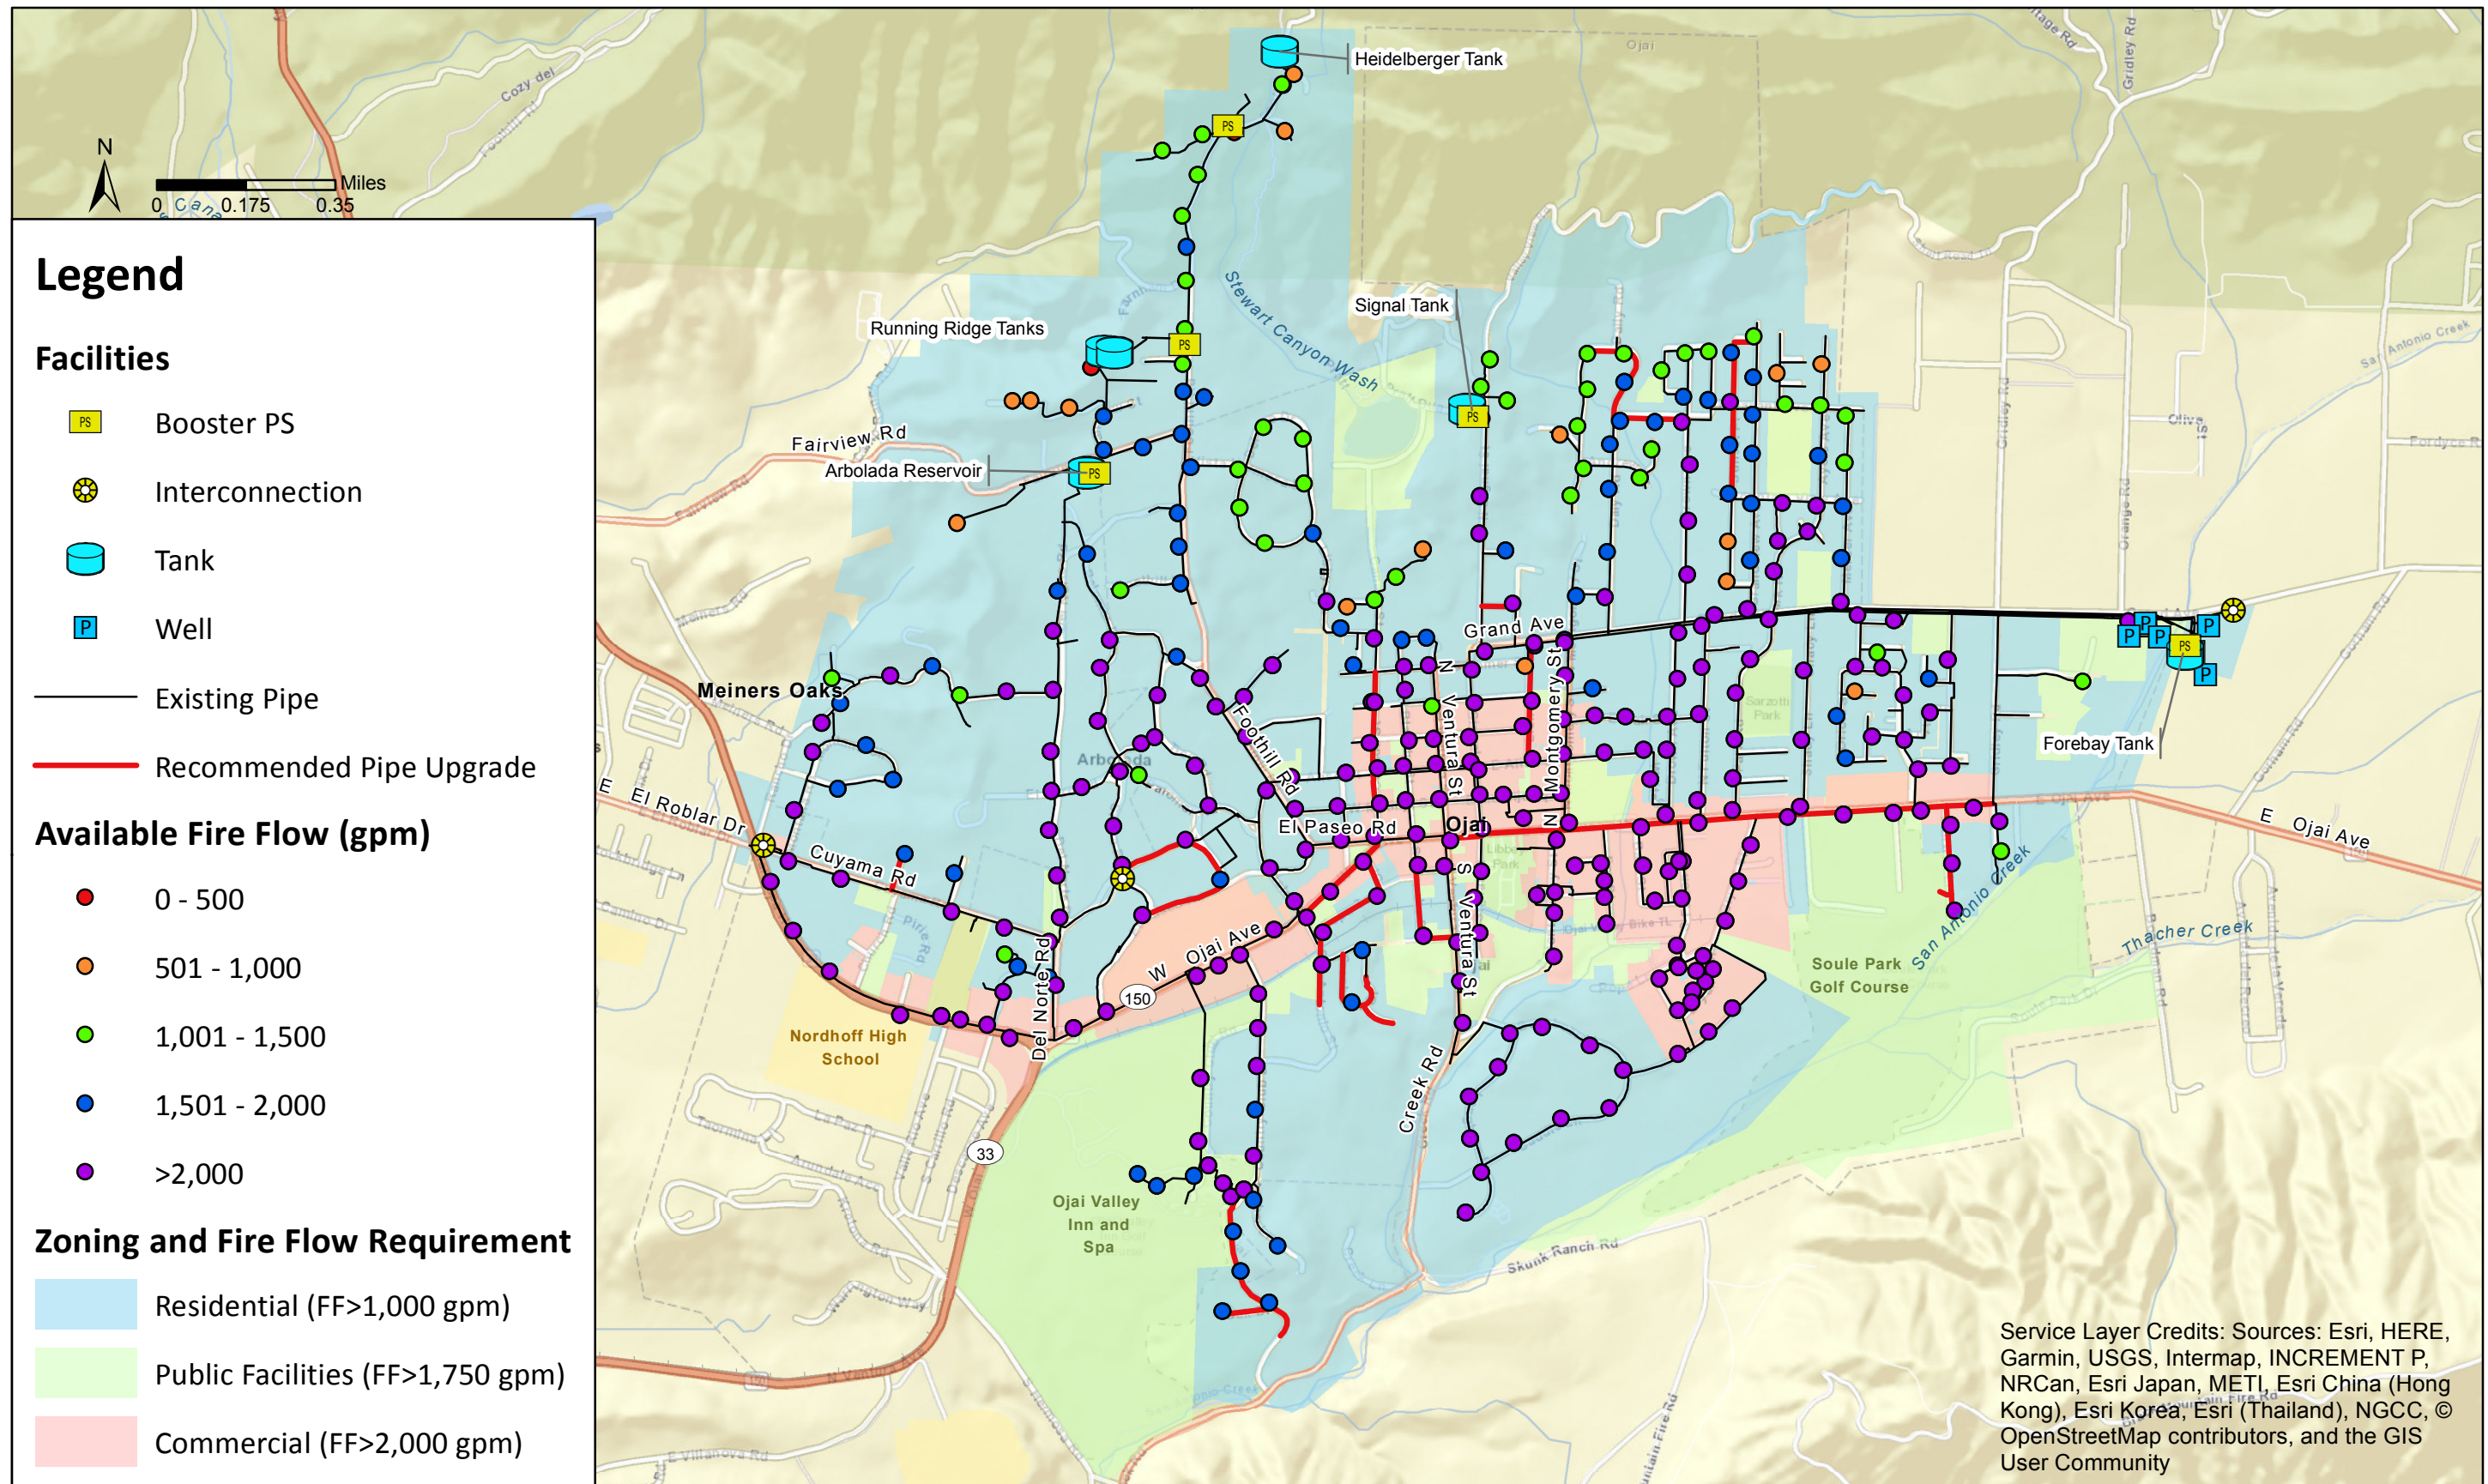
Figure 8-5. Available Fire Flow with Recommended Projects

Figure 8-5 shows the improved system fire flow with all the recommended projects completed. After the completion of the recommended projects most locations will meet or exceed the required fire flow. There are, however, some single isolated hydrants shown that cannot provide 1,000 gpm in residential areas. The hydrants are located off small diameter mains that restrict the fire flow, but are all located adjacent to a hydrant off a larger main that can meet or exceed the fire flow requirement. As mentioned, multiple hydrants will be used during a fire, so these isolated hydrants are considered adequate because the area can still maintain the required fire flow.

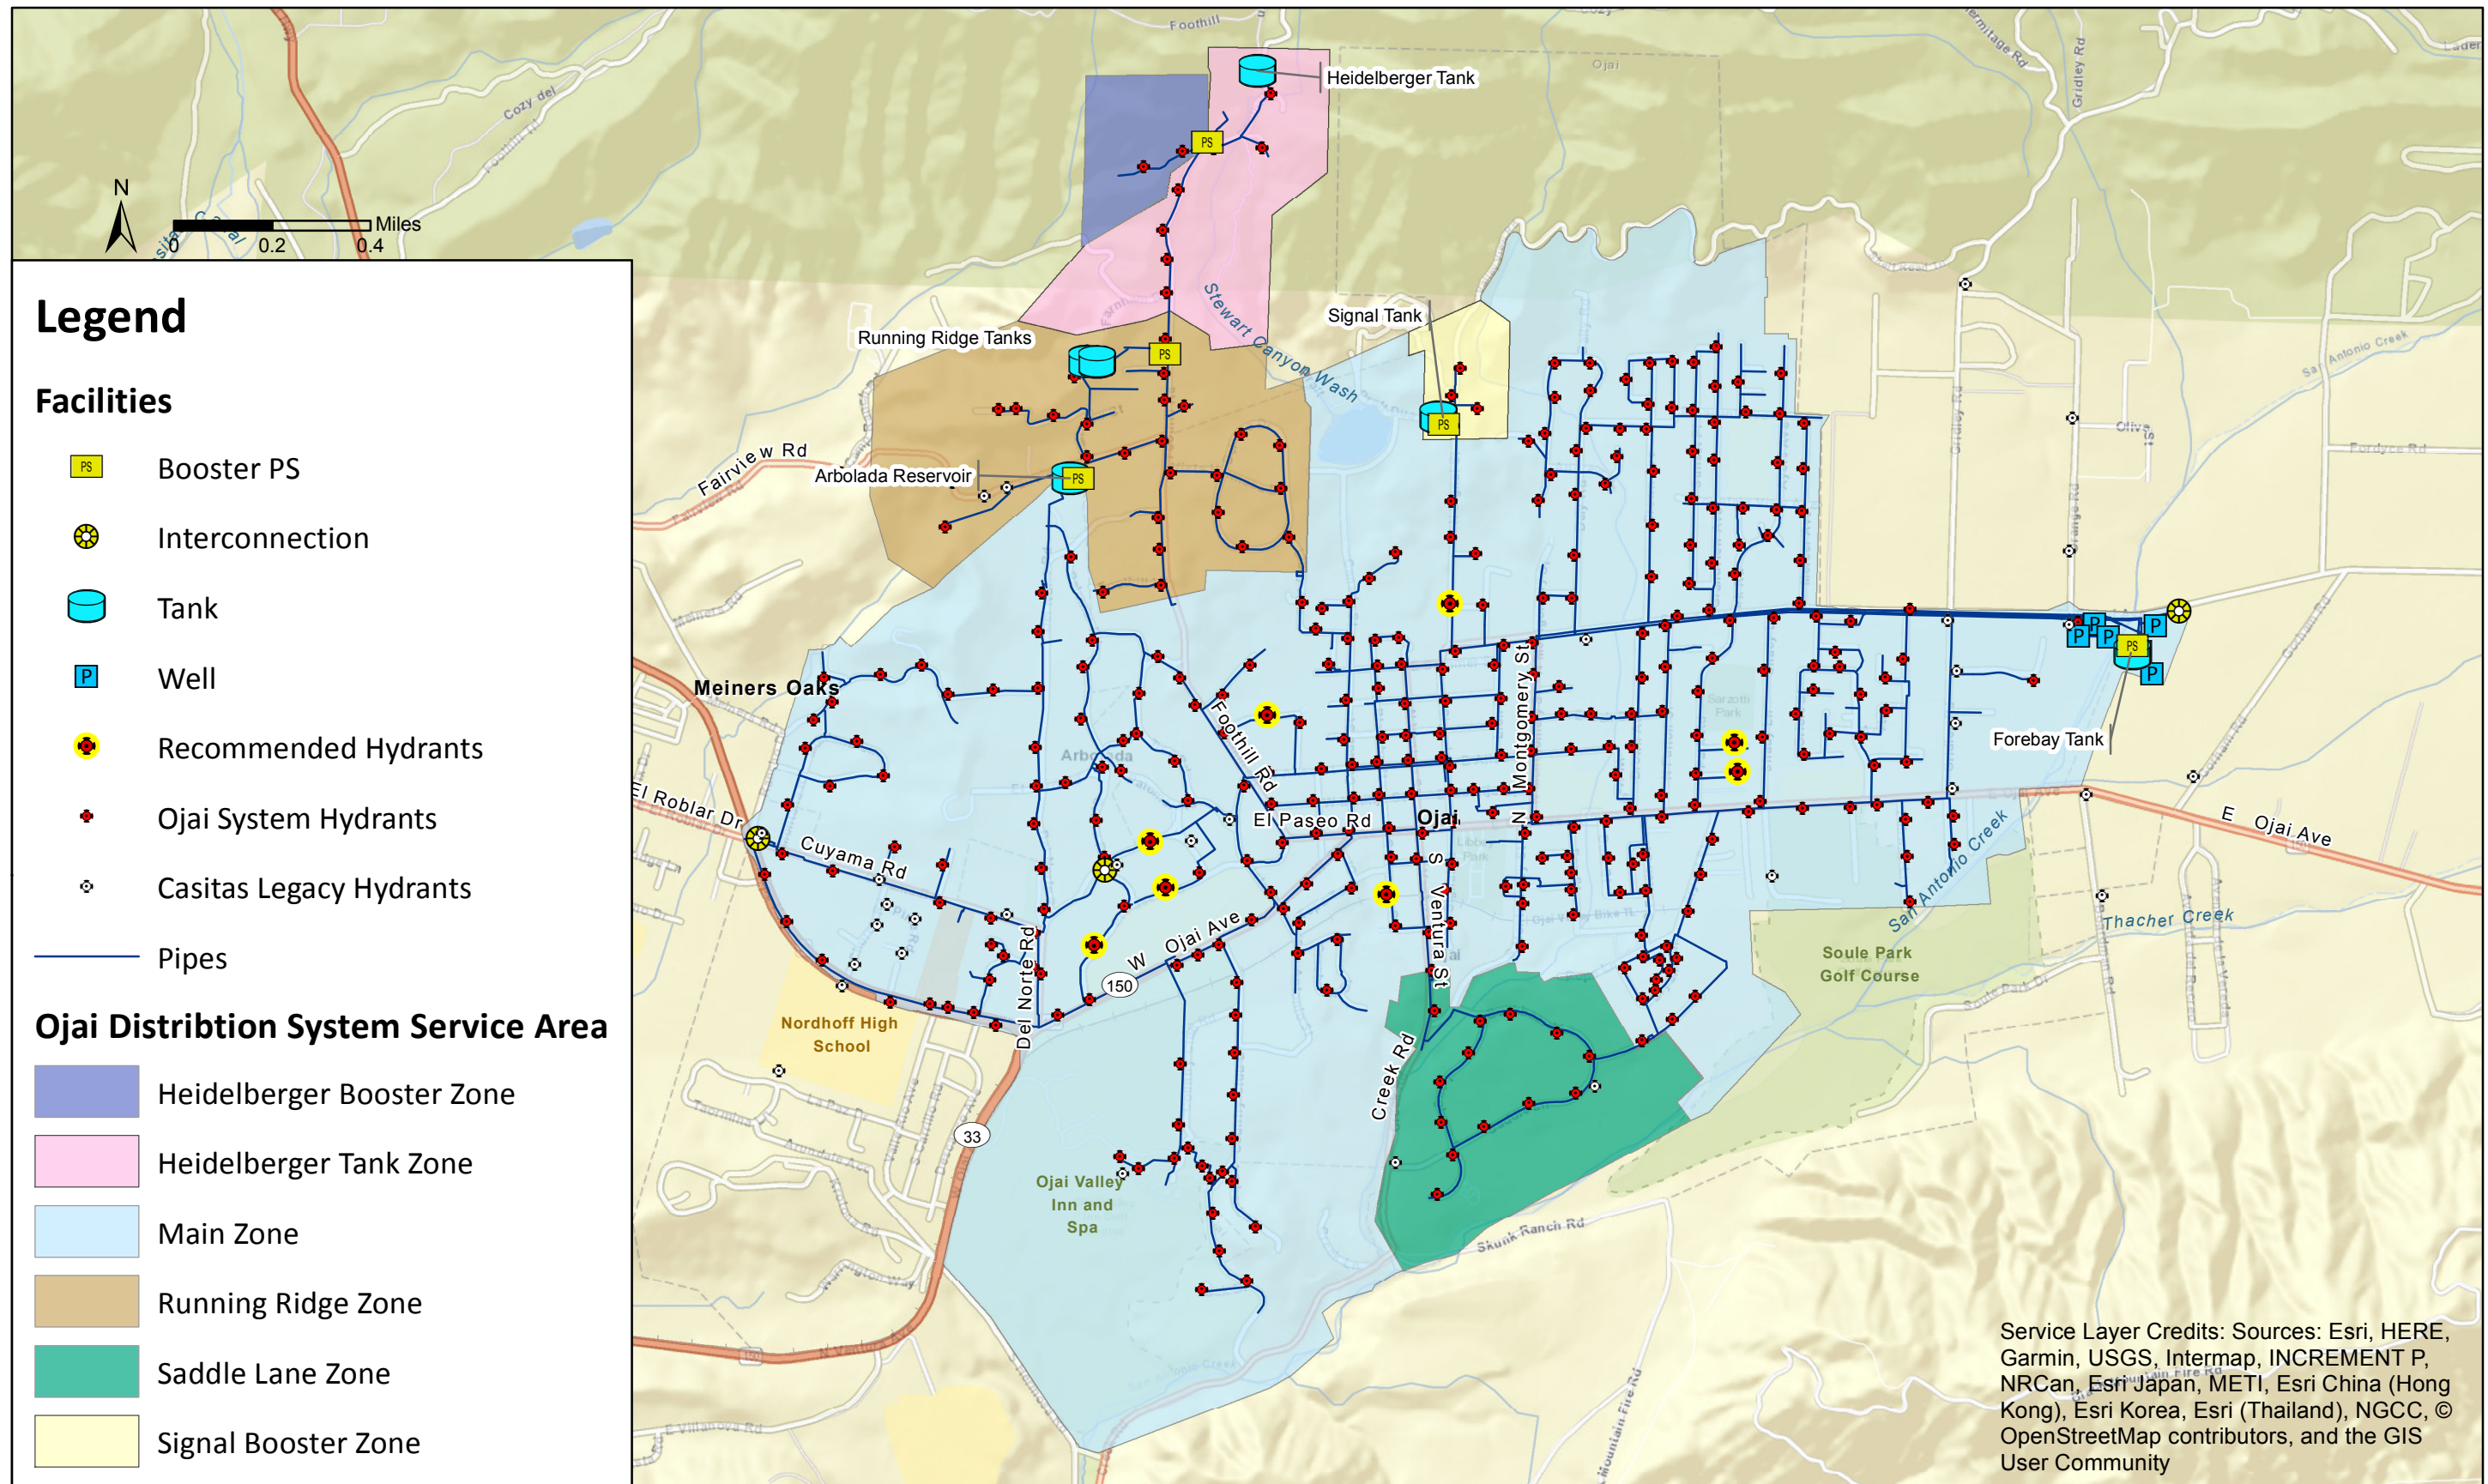
Figure 8-6. Recommended New Hydrants

The City of Ojai has hydrants connected to the Ojai water distribution system and the main CMWD water distribution system. Both system's hydrants were used to evaluate the hydrant spacing in the service area. As shown in Figure 8-6, 8 new hydrants are recommended in the distribution system to meet the hydrant spacing requirements. Of these recommended hydrants, 4 can be included with recommended fire flow projects listed in Table 8-2. This leaves 4 remaining hydrants to be installed on their own. Exact hydrant locations should be coordinated with the Ventura County Fire Department during design.

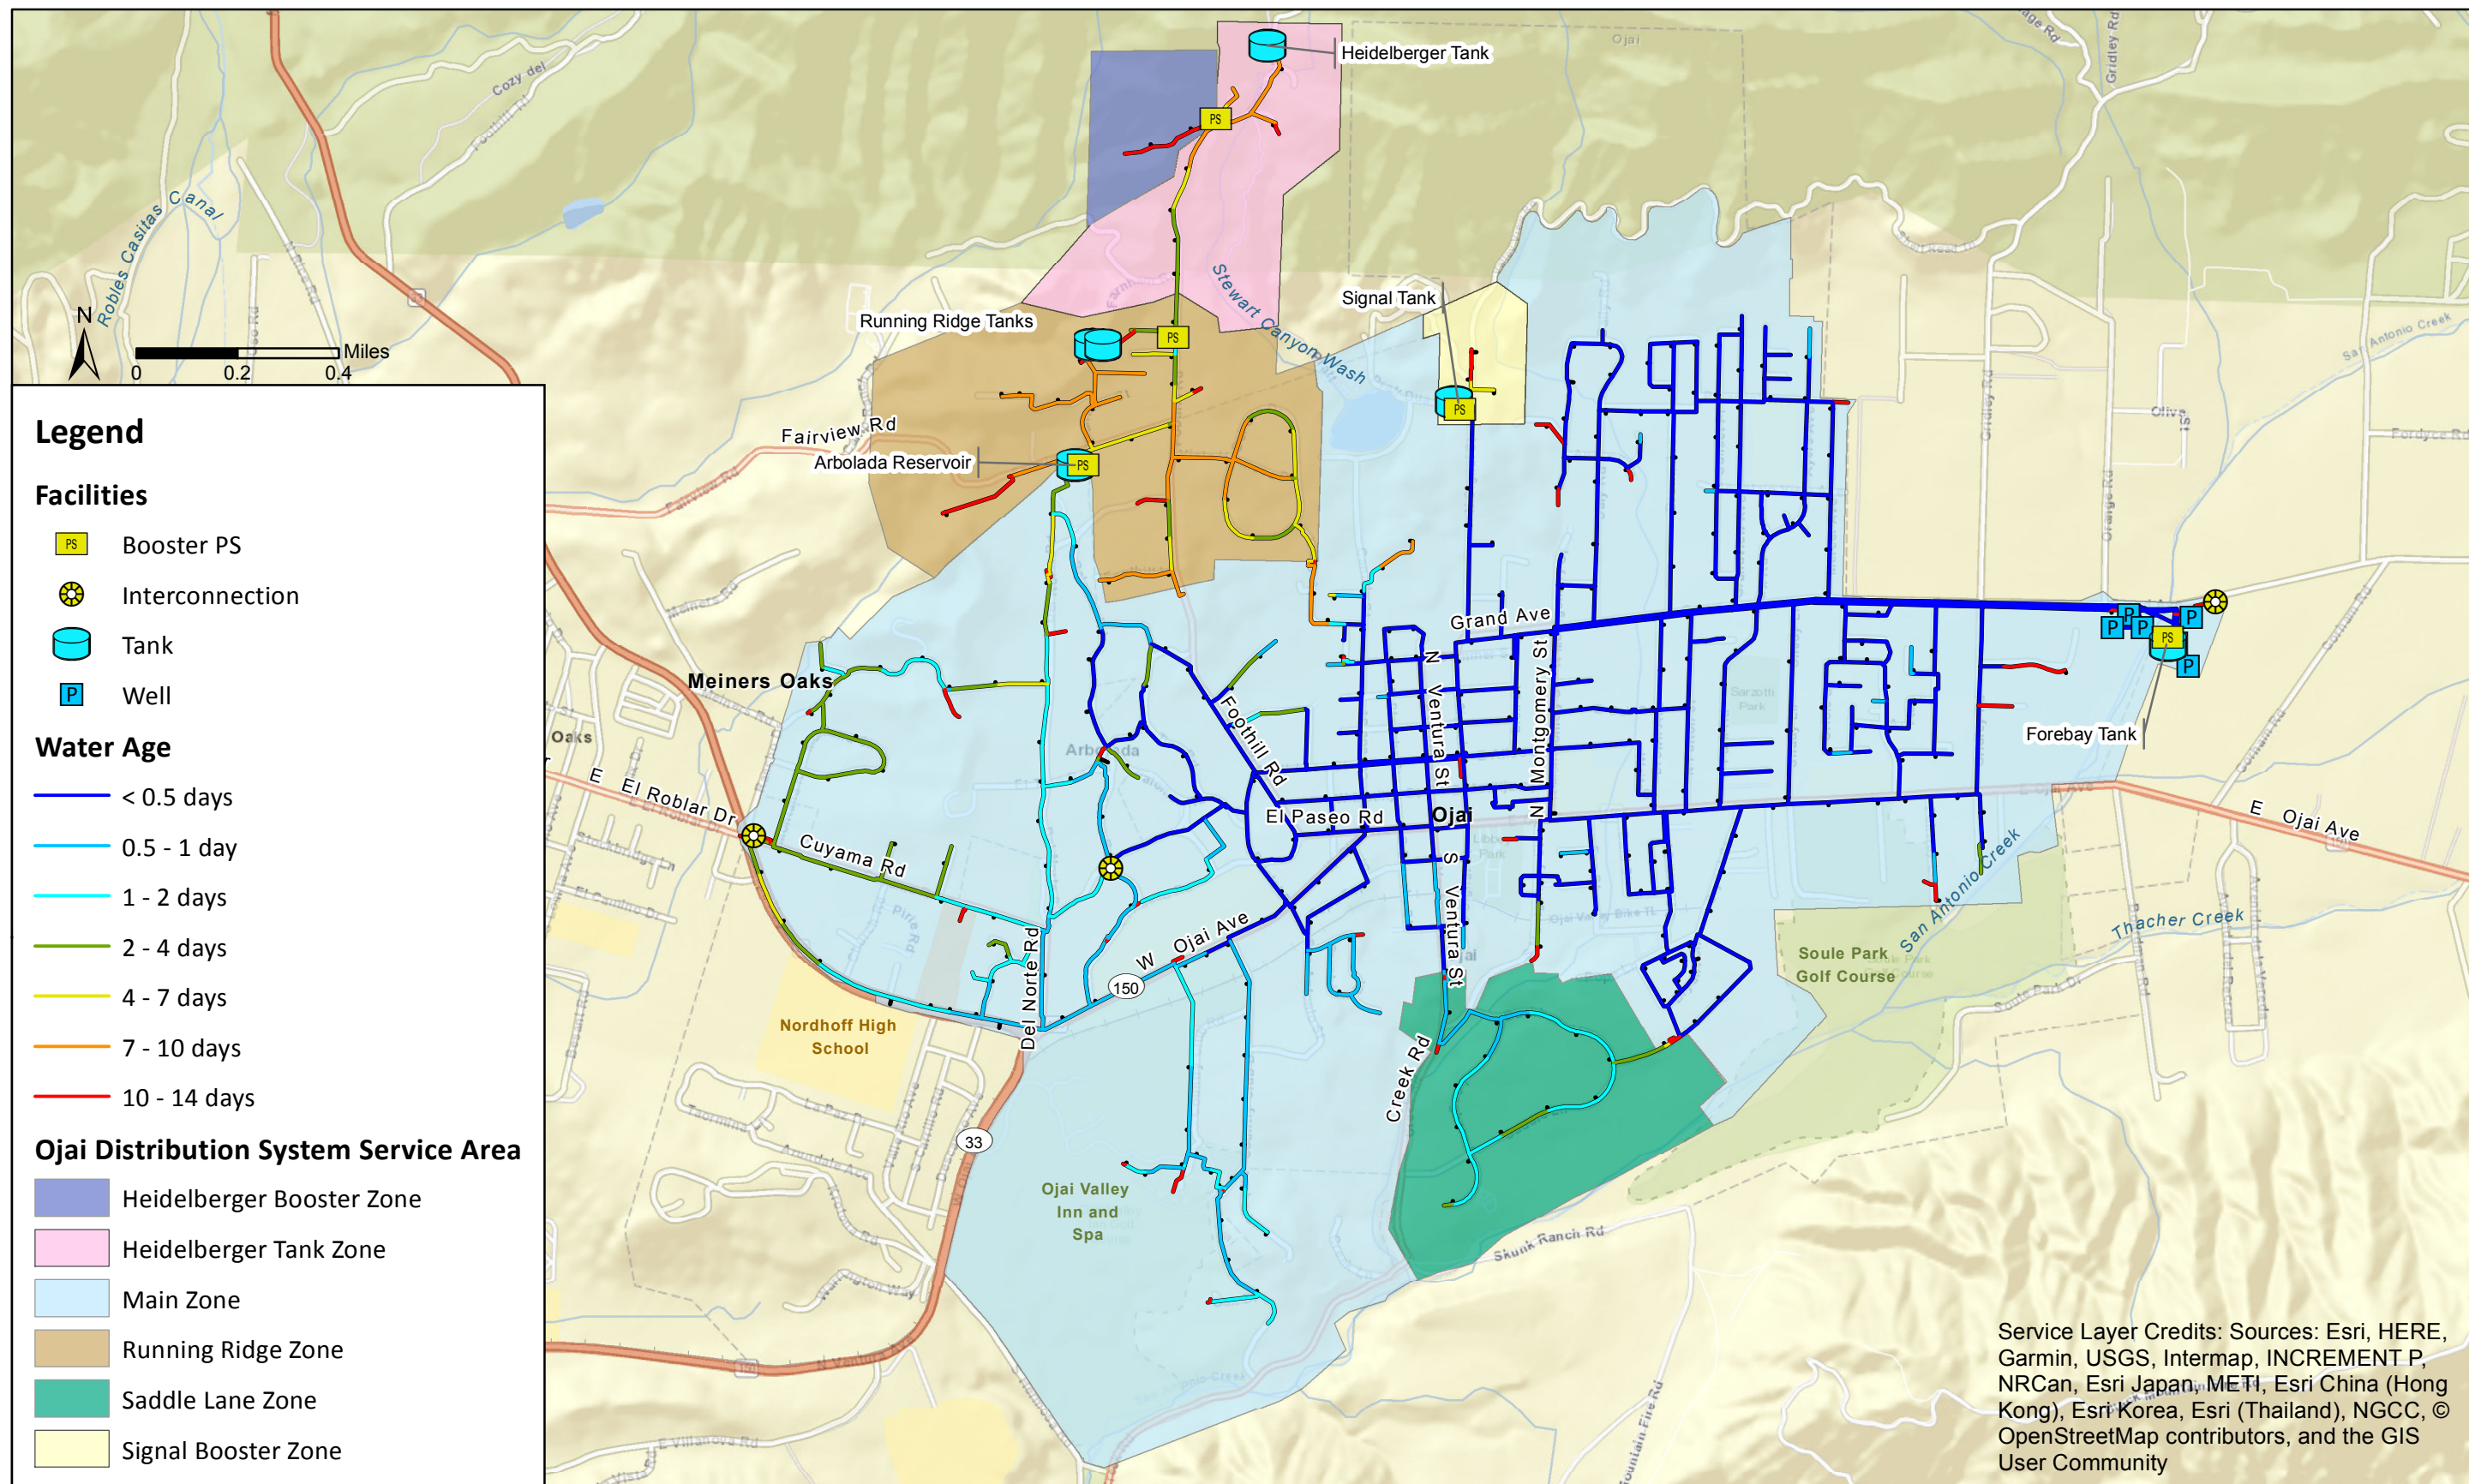
Figure 9-1. Modeled Water Age in the Ojai Distribution System

The water age was calculated in each pipe during a 14-day model run. Table 9-1 includes the average weighted water age in each zone and Figure 9-1 includes a map of the modeled water age in each pipe. It should be noted that the model was calibrated for only 24 hours and due to modeling limitations, the modeled water age is only an approximate water age.

Overall, the low modeled water age correlates to high water quality in the Ojai water distribution system. There are, however, some locations predicted to have older water that may impact water quality. These locations include dead end mains and are concentrated within the smaller zones with low demands. CMWD flushes water mains as required to maintain water quality, and it is recommended that this practice is continued. CMWD should also consider implementing a pipe flushing operation plan that includes annual pipe flushing of dead end mains. Pipe flushing is expected to improve water quality in the system more than any other operational change. In addition to pipe flushing, CMWD can occasionally bleed water from the Heidelberger Tank Zone to the Running Ridge Zone or lower the operating level of the Signal Tank to improve water age without increasing non-revenue water.

CMWD, similar to most water agencies, perform pipe flushing to maintain low water age and high water quality in the distribution system. It is recommended that operations staff continue pipe flushing, focusing on dead end mains, especially in the smaller zones. Pipe flushing, though a necessary operation to improve water quality, increases non-revenue water demand. The hydraulic model was used to evaluate potential solutions to reduce water age in the system without increasing non-revenue water, including bleeding water between pressure zones and lowering reservoir levels to increase reservoir turn over. The water age was modeled bleeding water from the Running Ridge Zone to the Main Zone and bleeding water from the Heidelberger Tank Zone to the Running Ridge Zone. When bleeding water between zones, CMWD needs to be careful not to over pressurize the lower pressure zone. Due to storage requirements, only the Signal Reservoir can be significantly lowered and the storage requirements maintained. These 3 scenarios were set up in the model and the water age results are described below:

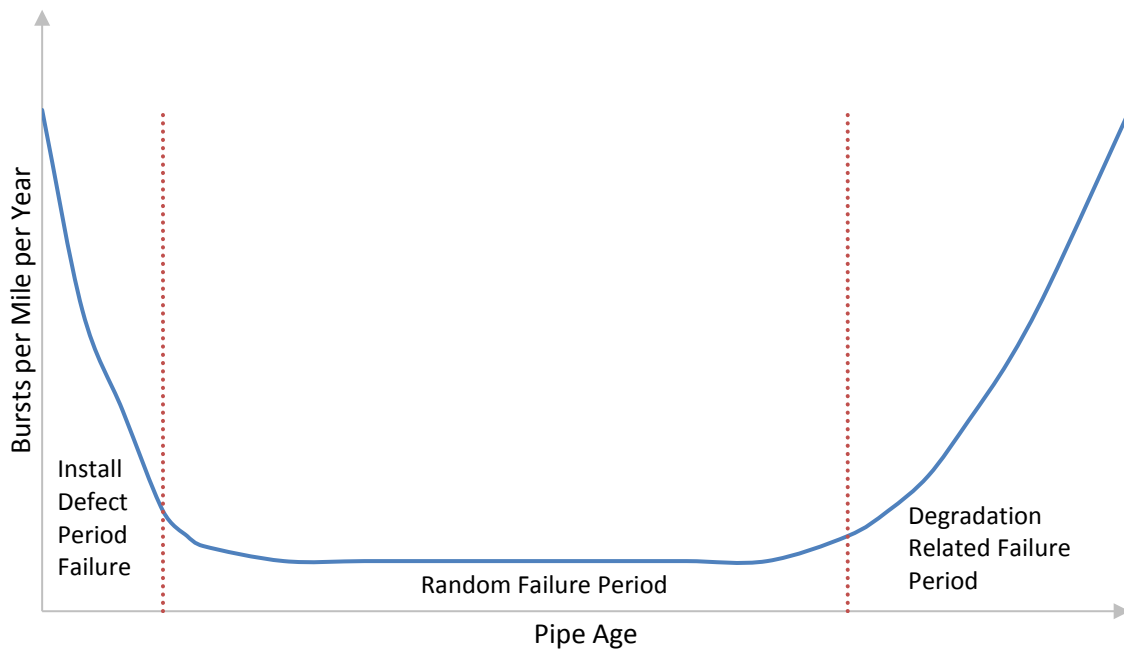
Figure 10-2. Classic Failure Curve for Pipes (9)

Shown in Figure 10-2, most pipe failures fall into 1 of 3 failure modes: the install defect failure period, the random failure period, and the degradation related failure period. Any failures in the first category should be prevented by proper design, installation, and inspection. Random failures cannot be predicted, but the system should be surveyed regularly to identify and repair these random leaks. This analysis focuses on the pipe failure due to degradation because much of the Ojai water distribution system is reaching the end of its useful lifetime.

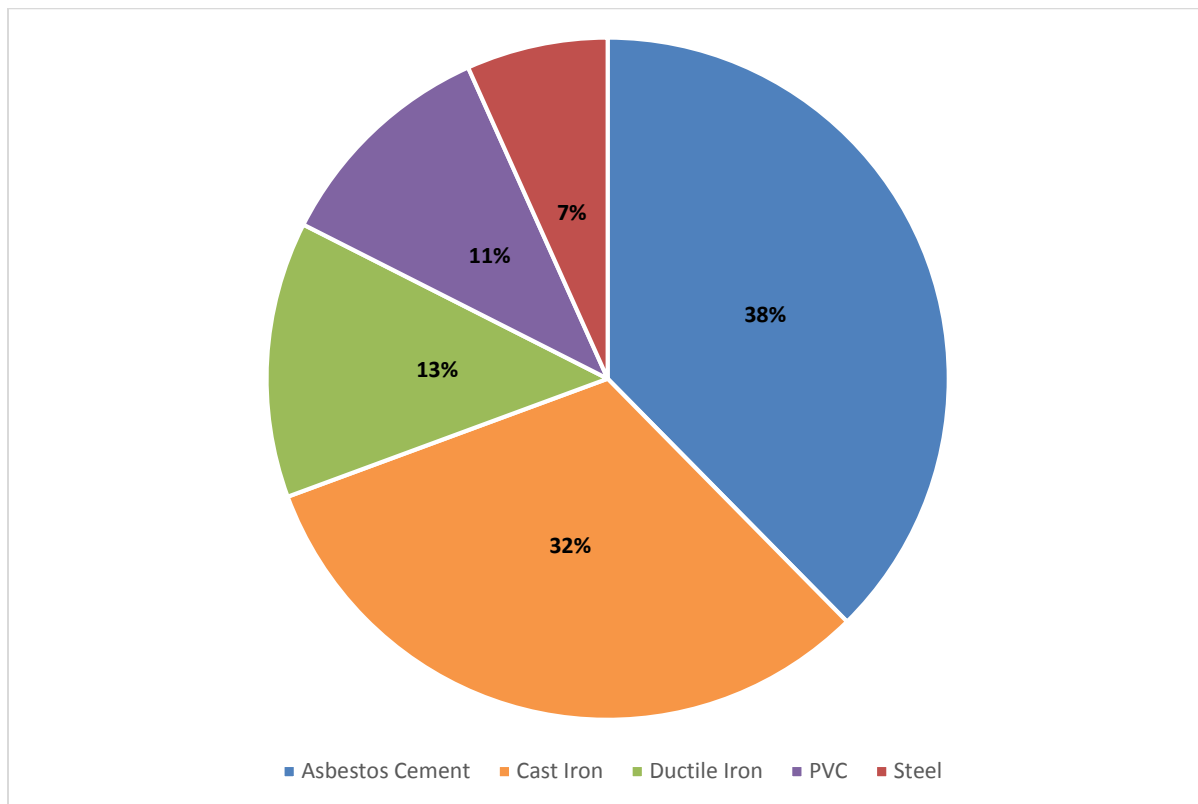
Figure 10-3. Percentage of Pipeline Materials within the Distribution System

Figure 10-3 displays the percentage of each material that currently comprises the water distribution system. 70% percent of the distribution system is comprised of cast iron pipe or asbestos cement pipe.

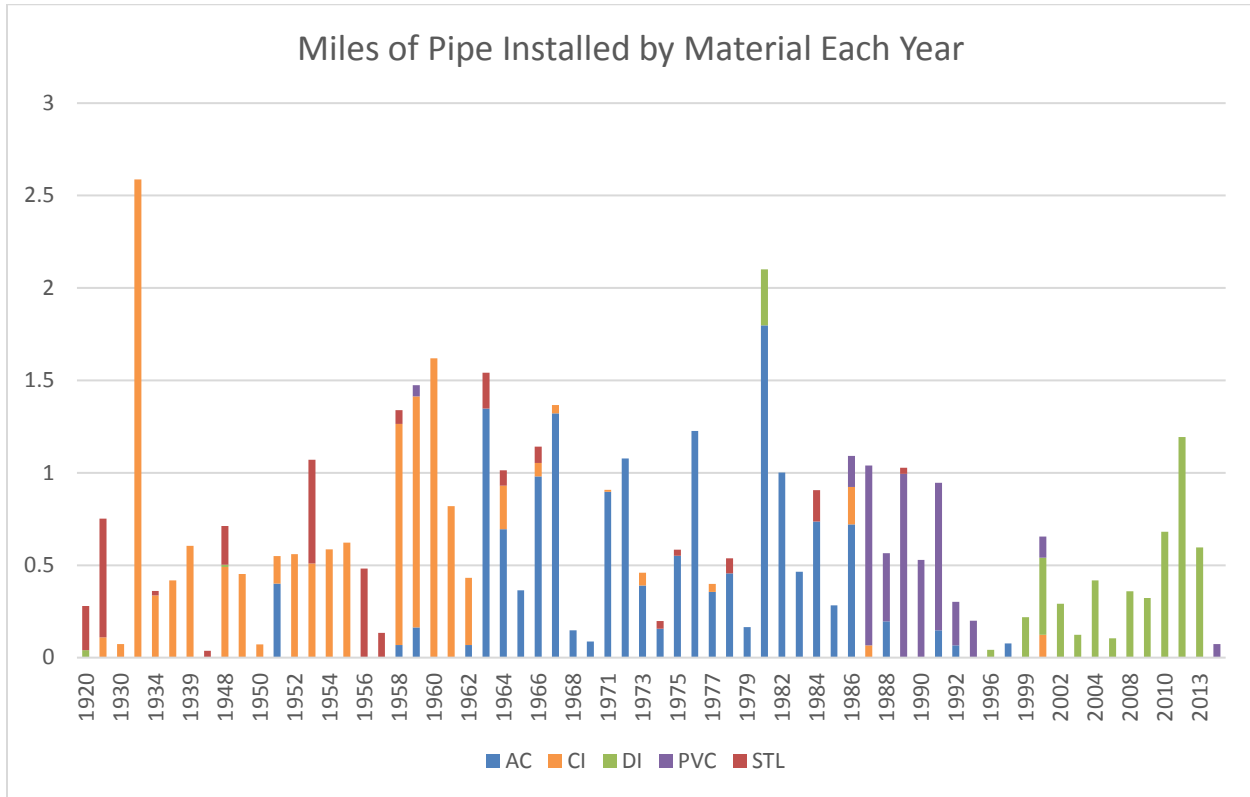
Figure 10-4. Miles of Pipe Installed by Material Each Year

Typically, water distribution systems contain multiple types of pipe material. This can be due to site specific requirements where a certain pipe material is preferred for the function of the pipe, but in most cases the pipe material used is a function of the most popular pipe material based on the installation date. Cast iron and steel pipe were popular in the early to mid 1900s, but could not compete with the non-corrosive nature of asbestos cement in the Western United States from the 1960s through the 1980s. Asbestos cement pipe was phased out in the United States in the late 1970s and both ductile iron and PVC pipe are currently some of the more popular pipe materials used in water distribution systems, along with other highly specialized pipe materials. Figure 10-4 shows the number of miles of pipe installed each year by material. In this figure it is clear what the preferred water pipe materials were for each decade in Ojai.

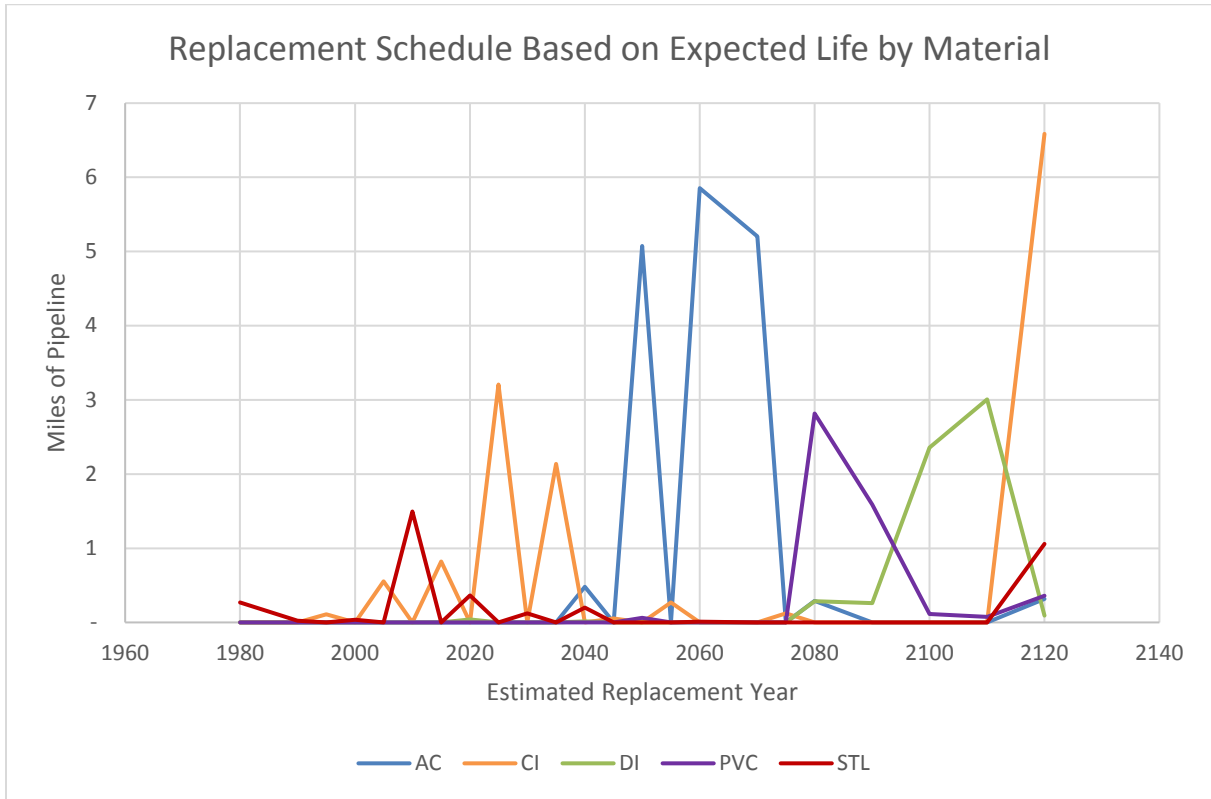
Figure 10-5. Replacement Schedule Based on Expected Life by Material

Based on the pipe install data and estimated useful life by material, it is recommended CMWD immediately implement an annual pipeline replacement plan to prevent costly emergency pipe failures. The miles of pipe expected to fail each year by material and in total are shown in Figure 10-5 and Figure 10-6, respectively. To ensure that specific capacity and condition projects are not double counted in this analysis, the recommended pipeline projects listed in the final CIP are assumed to have a future failure date of 2120 with a 100-year service life for each project. Because of this assumption, the analysis shows a large failure of pipes, predominantly cast iron, in 2120. These pipes are assumed to be replaced by 2020 with PVC pipe and have a useful life through 2120, but are shown below as their current pipe material. Without double counting recommended projects, many for pipelines near the end of their useful lives, this analysis predicts an additional 3.3 miles of pipeline that have currently exceeded their useful lifetime and have a high risk of failure. These pipelines include steel and cast iron pipe originally installed in the 1920s and 1930s.

This analysis also predicts that pipelines will fail in large groups similar to how they were installed, then have periods with little expected pipe failures. It is recommended that pipes are replaced before they are expected to fail to prevent extremely costly repairs during an emergency main break. Typically, emergency repairs of such infrastructure like water mains costs 3 to 4 times higher in an emergency situation compared to regular repairs (10).
